Boundary Dam – Generator 53 Repair Recommendation Report

Prepared by:
Andrew Strong
Power Production Program Manager
Seattle City Light

Attachment 1 to
SCL Boundary Unit 53 Allocations FISC

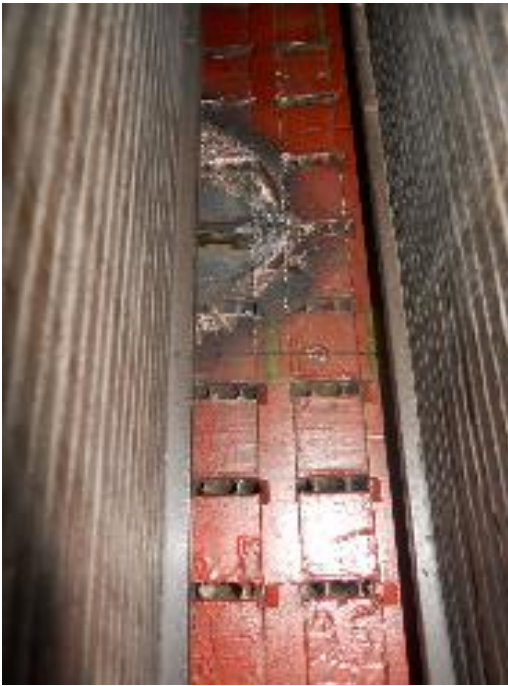
On 5/2/13 Voith arrived on site to access the damage to unit 53 generator at Boundary Dam. During the inspection it was visible what appears in slot 254 that a coil had gone to ground in the core slot. There was signs molten core iron on the face of core, separation of laminations, plus core slag in the back of the frame. Also heated black carbon smoke in the area. Plus on the rotor poles there is a metallic material adhered to them.

Damage to Unit 53

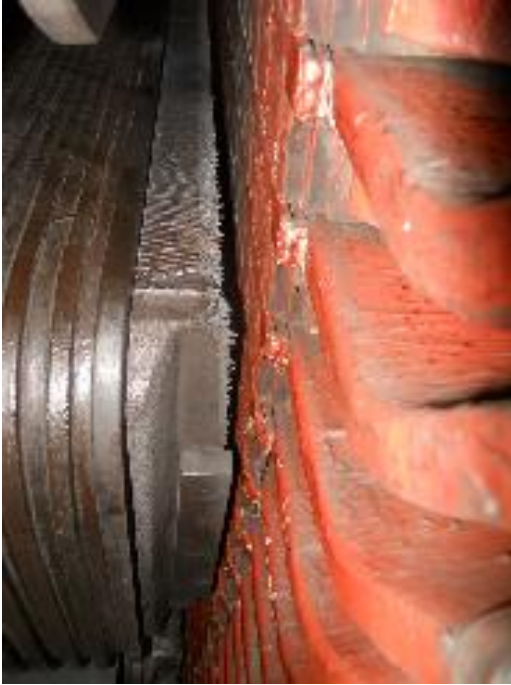
Unit 53: Rotor pole metallic material

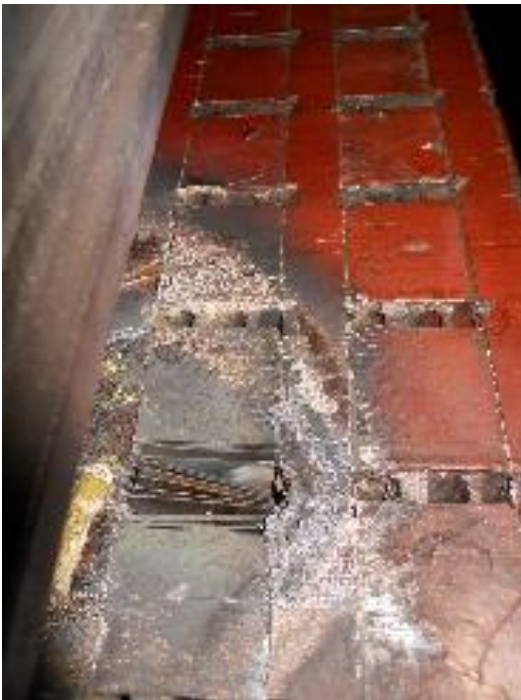
Unit 53: Separation of laminations

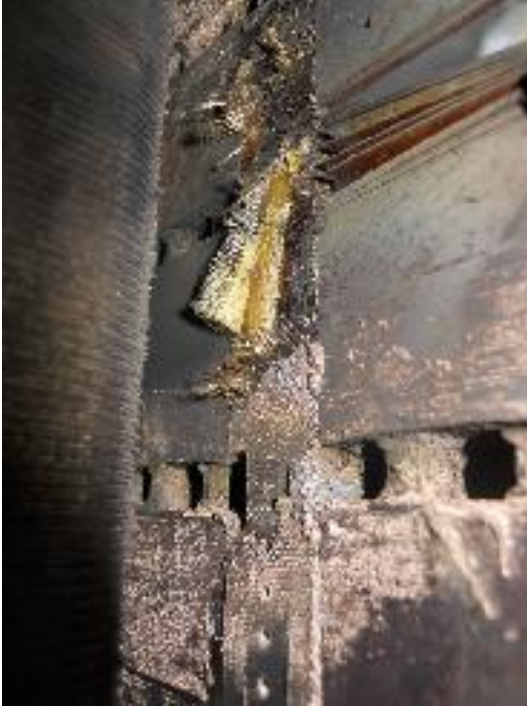
Unit 53: Separation of laminations

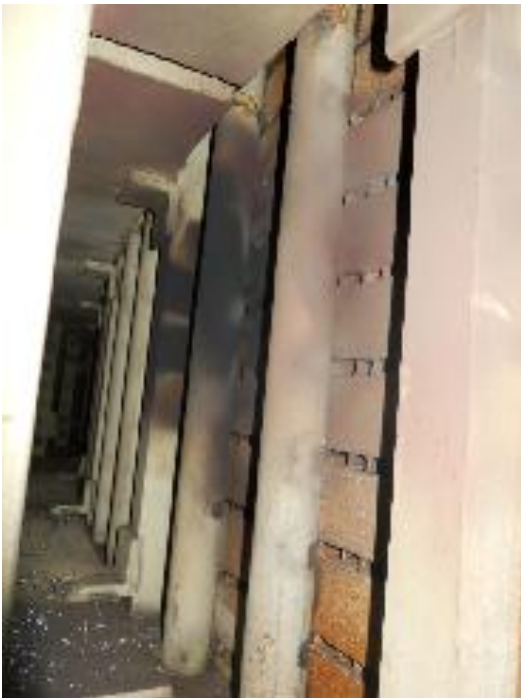
Unit 53: Note slag from damage to core
