CITY OF
SEATTLE
FACILITY
ASSESSMENTS

INTRODUCTION

The objective of this document is to provide construction cost estimates for specific repairs at (5) five mutual and offsetting benefit (MOB) properties owned by the City of Seattle. The repairs considered were identified based on the direction given by Statement of Legislative Intent (SLI) #2012-58-1-A-2.

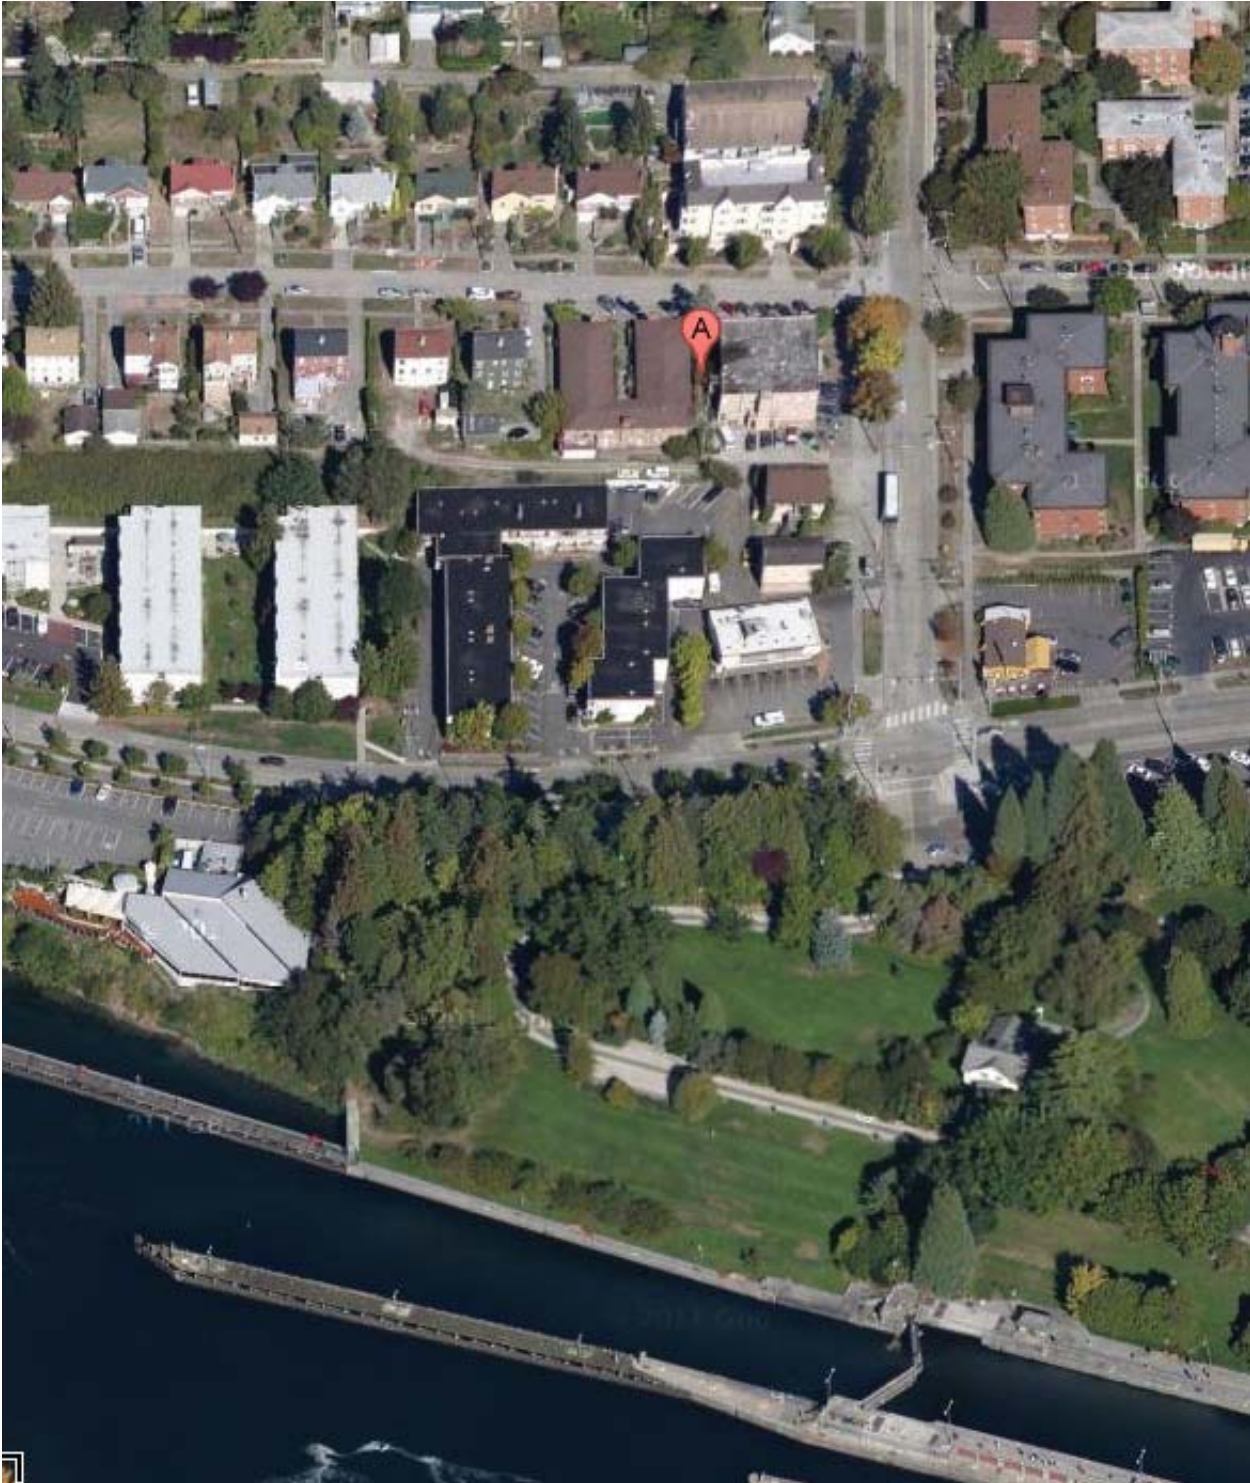
| Repair / Maintenance | | Estimate |
|---|---|---|
| 1 | Replace loose parquet wood floor tile; door threshold too high - 10 sf | \$750 |
| 2 | Install panic hardware on this exit way door | \$250 |
| 3 | Secure firemen override keys for elevator - currently left in 2nd floor override | \$0 |
| 5 | Replace (3) non functional radiators on second floor | \$1,500 |
| 6 | Boiler is 25 years old and nearing end of life. Budgetting for future replacement should be considered. | \$15,000 |
| 7 | Provide duct smoke detector in (2) ventilation air handling units for shutdown | \$3,000 |
| 8 | Remove abandoned 120/240V fused breaker pullman panel - no short circuit rating | \$1,200 |
| 9 | Provide smoke detector outside elevator on 2nd floor in existing j-box | \$480 |
| 10 | Provide smoke detector in elevator machine room | \$480 |

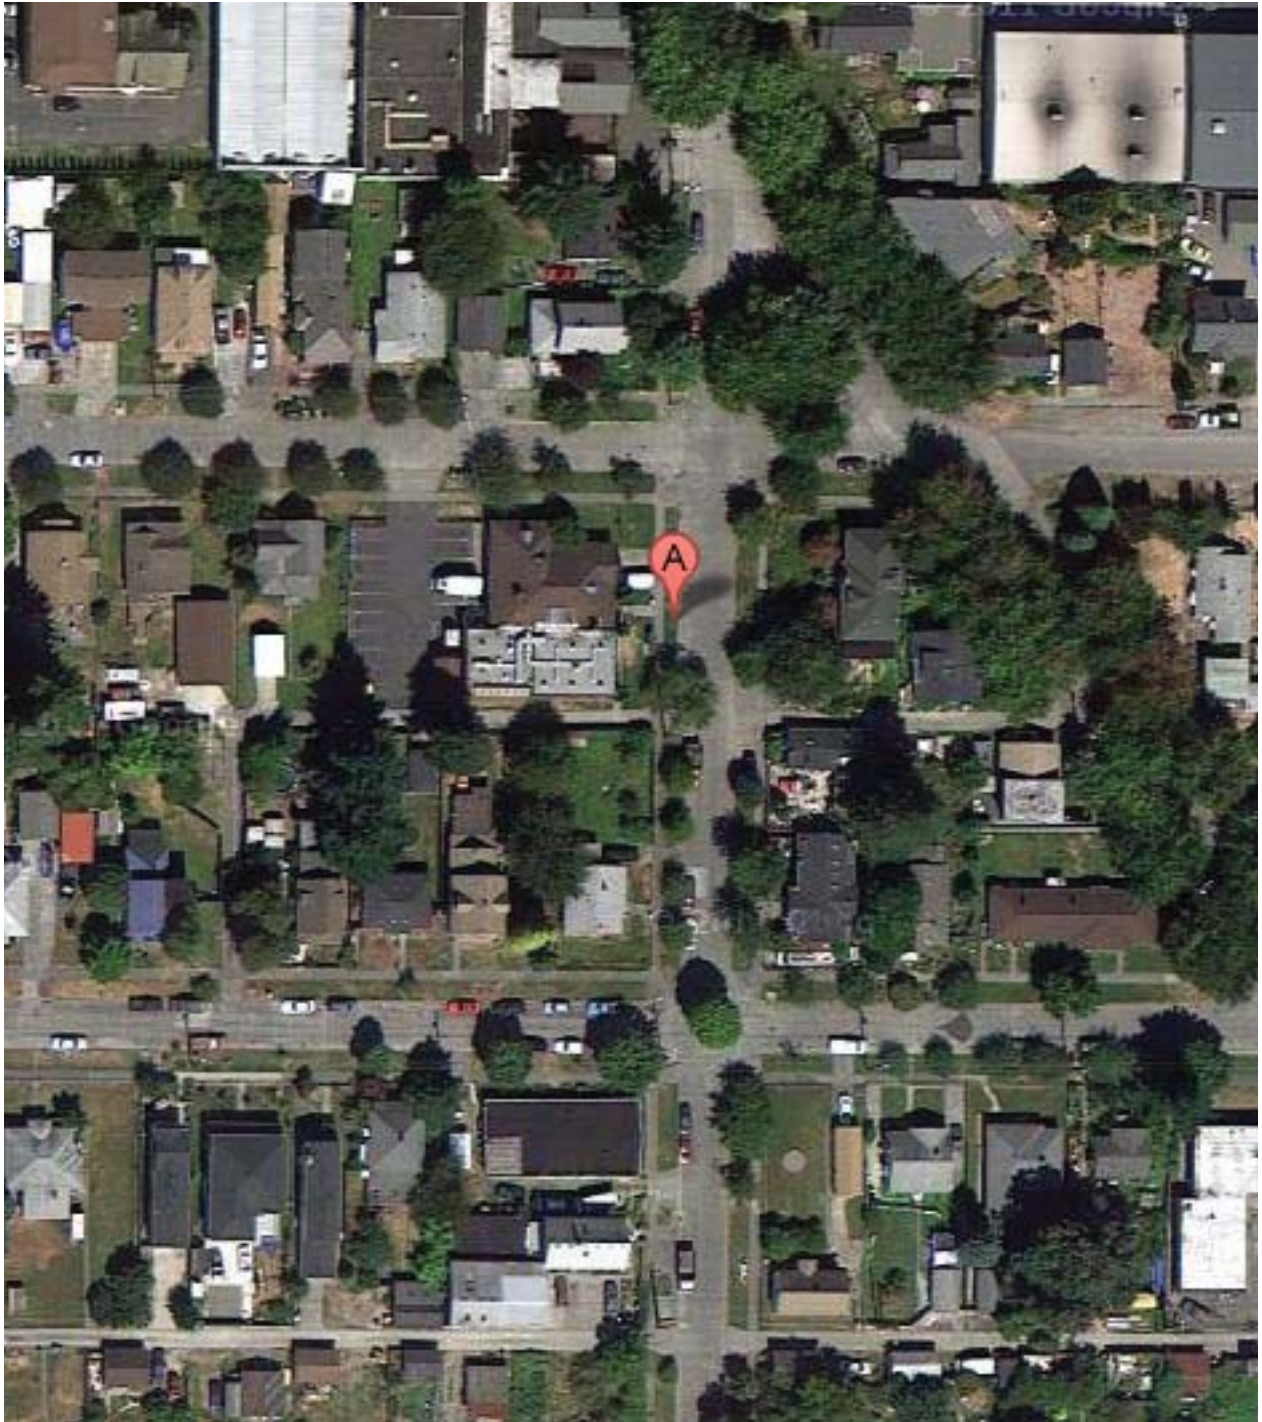
| Repair / Maintenance | Estimate |
|--|---|
| 1 VCT flooring missing tiles | \$200 |
| 2 Door pull too high for ADA accessibility; push side clearance lacking | \$450 |
| 3 Panic hardware and closers missing; door width not wide enough | \$3,000 |
| 4 Exit signage needed above door; threshold at exterior not accessible for WC | \$225 |
| 5 ADA parking stall provided but no accessible route to building | \$600 |
| 6 Exit signage needed above door | \$300 |
| 7 Panic hardware necessary OR accessible window and light well needed for egress | \$250 |
| 8 Replace multi-purpose room gas furnace | \$15,000 |
| 9 Cap return duct in greenhouse, rebalance return ductwork | \$500 |
| 10 Remove transfer grill in greenhouse, infill wall | \$500 |
| 11 Provide electric unit heater and thermostat for greenhouse | \$600 |
| 12 Replace heat detector | \$600 |
| 13 Flush floor 120V outlets - remove wiring and outlet, fill with concrete | \$1,440 |

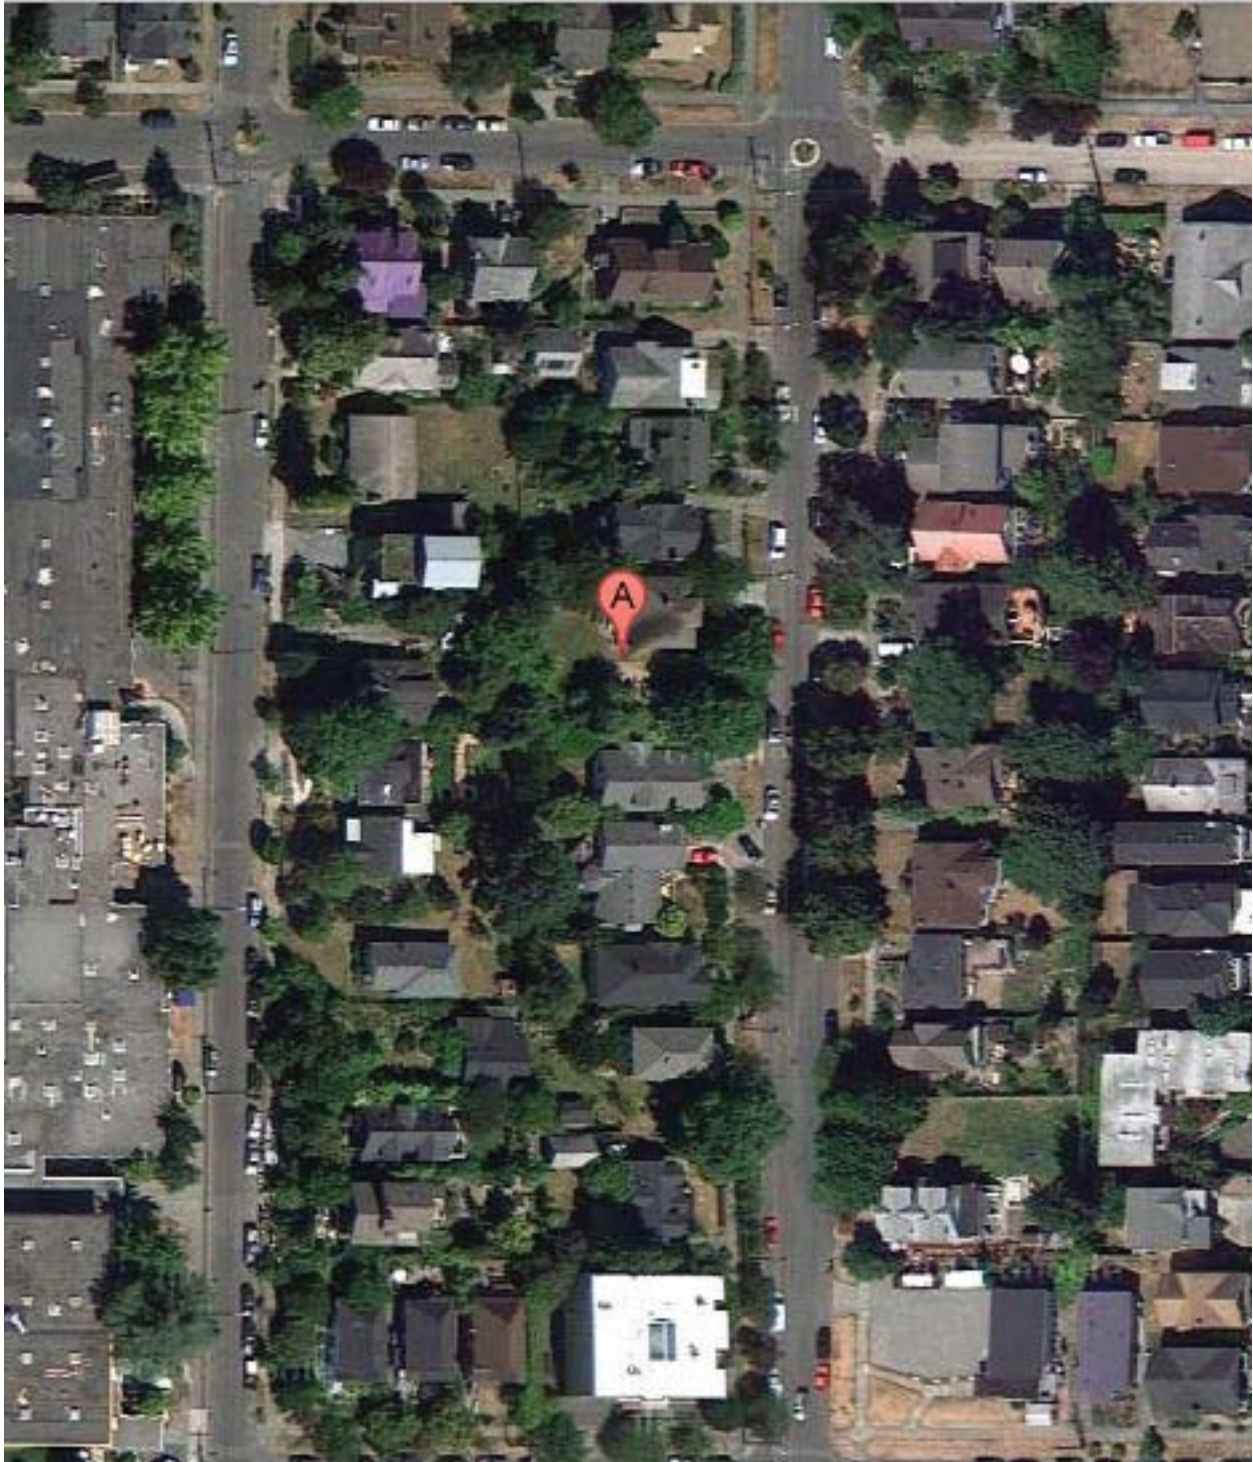
| Teen Parent Home | | |
|---|--|---|
| 1 | Signage for fire alarm control panel | \$200 |
| 2 | Handrail replacement necessary (5 LF) | \$200 |
| 3 | Add handrail (25 LF) | \$750 |
| 4 | Furnace is 25 years old and nearing end of life. Budgetting for future replacement | \$15,000 |
| 5 | Provide flex pipe gas connection to furnace | \$200 |
| 6 | Remove tape covering smoke detectors | \$60 |

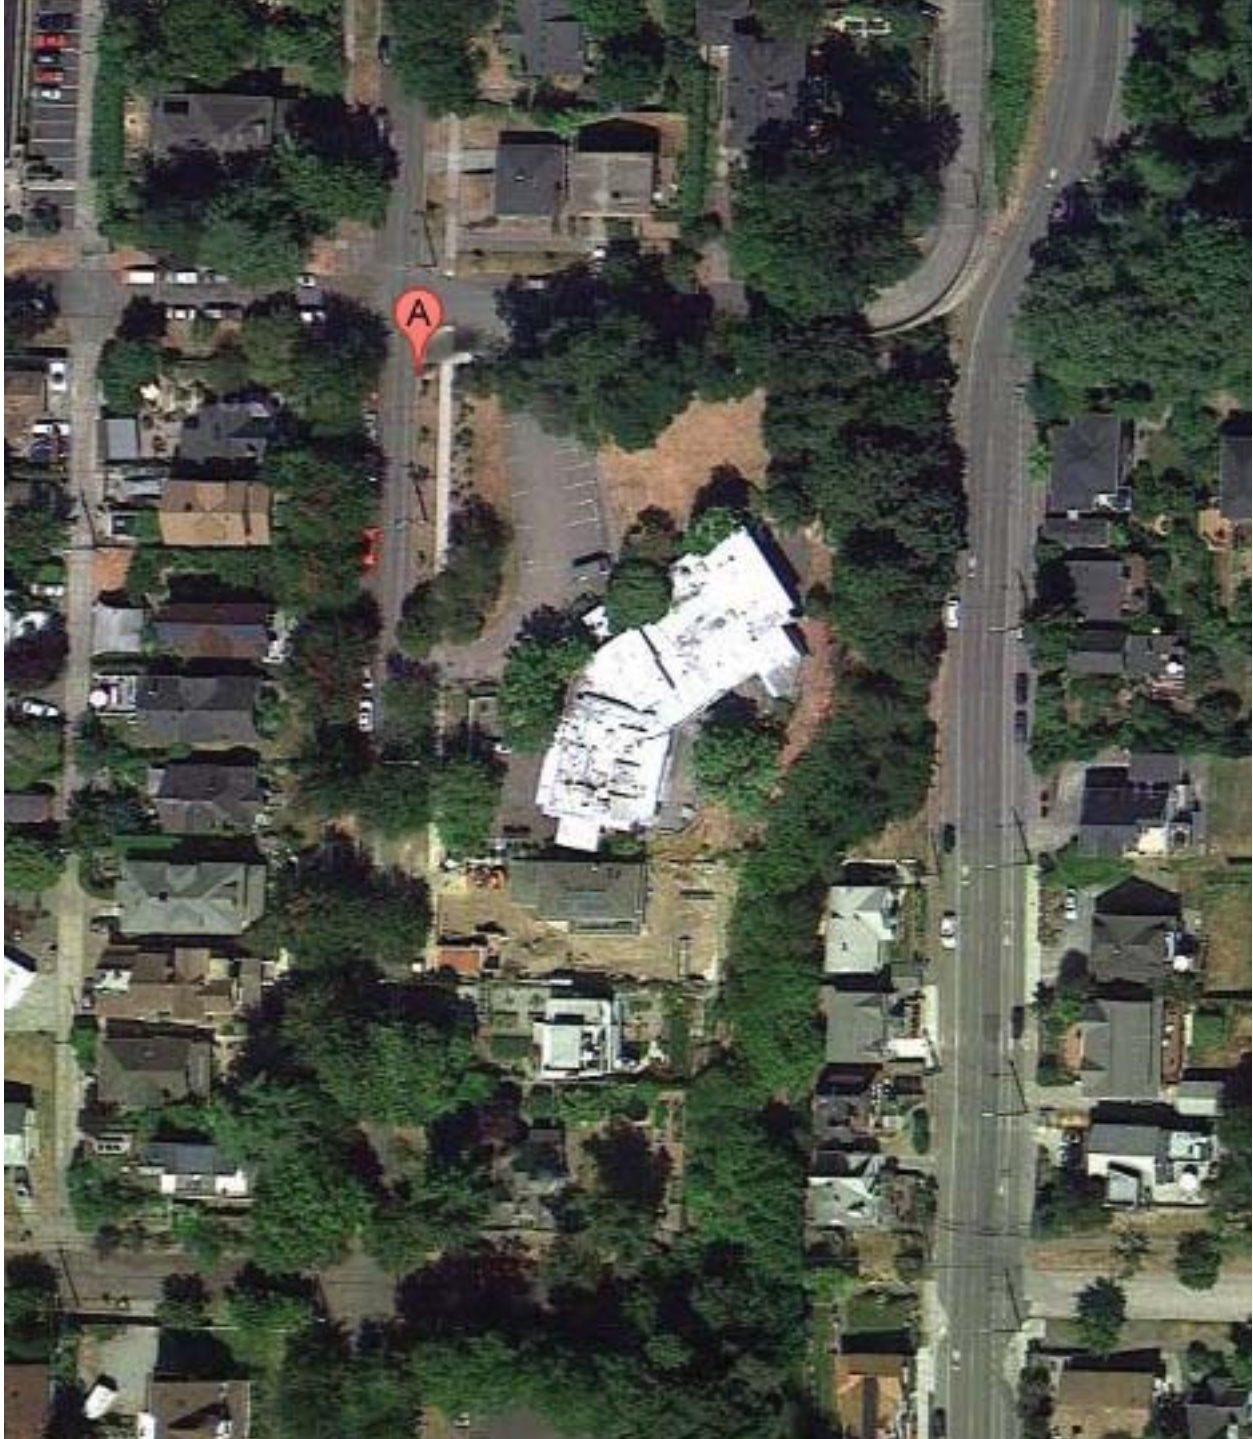
| Repair / Maintenance | Estimate |
|---|---|
| 1 Bury downspout under walk-way | \$250 |
| 2 Door too narrow, not accessible | \$3,000 |
| 3 Evidence of clerestory glazing leaking water | \$720 |
| 4 Threshold repair necessary | \$150 |
| 5 Door swing / clear floor area non compliant | \$450 |
| 6 Egress signage is needed in storage room being used as a "vintage clothing room" | \$200 |
| 7 Provide duct smoke detector in ventilation air handling unit for shutdown | \$1,500 |
| 8 Replace Bollard lights - waterseal broken, showing condensation, post loose at base | \$4,800 |
| 9 Replace exterior fixtures showing water damage - breezeway | \$432 |
| 10 Verify de-energized, abandoned FACP and remove - NW storage room | \$1,200 |
| 11 Replace non-AIC rated power panels from 1959 (120/208V, 3ph, 300A SE, 200A Pnl) - includes demo cost | \$16,800 |
| 12 Relocate Panel C - water piping located directly above panel - basement | \$3,600 |
| 13 Seal 3" conduit penetration at exterior entrance wall - numerous exposed conductors | \$600 |
| 14 Flush floor 120V outlets - remove wiring and fill with concrete | \$600 |
| 15 Provide cover to j-box AND relocate for working clearance - above FACP | \$360 |

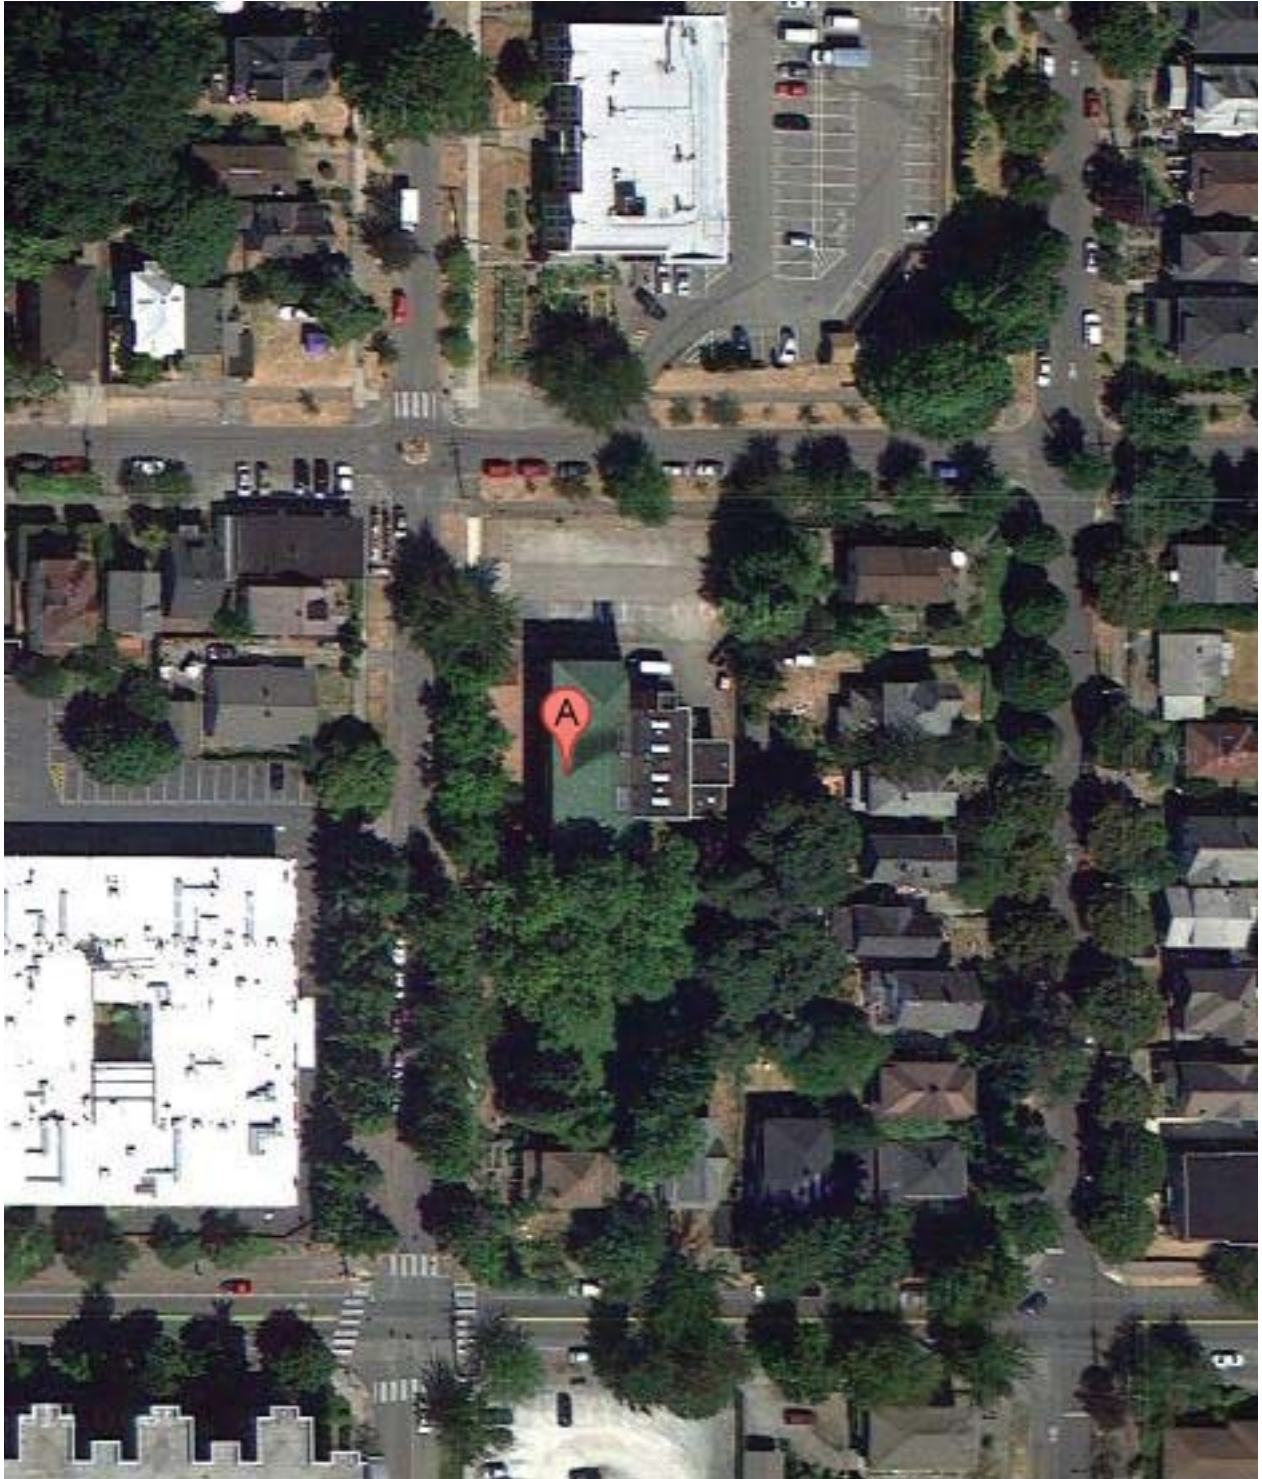
| Repair / Maintenance | Estimate |
|--|---|
| 1 Cracked glazing at skylight | \$825 |
| 2 Step in door at threshold is tripping issue (noted but NO repair) | \$0 |
| 3 Door threshold non-compliant (too high, cut down) | \$350 |
| 4 Provide duct smoke detector in air handling unit for shutdown | \$1,500 |
| 5 Replace Zinsco 120/240 panelboards, 225A, 30P | \$43,200 |
| 6 Replace Zinsco main distribution panel, 800A, 120/240V | \$14,400 |
| 7 Provide smoke detectors in food bank distribution area and east 1st floor storage rooms | \$2,880 |
| 8 Relocate power panel and Siemens control panel in boiler room - water piping installed above | \$7,200 |
| 9 Replace 2 rusted and damaged steel conduits above Panel F | \$1,080 |
