# SPU Bike Safety Program

# *Objective*

Reduce potential risks  
associated with SPU  
assets in the street  
R-O-W.

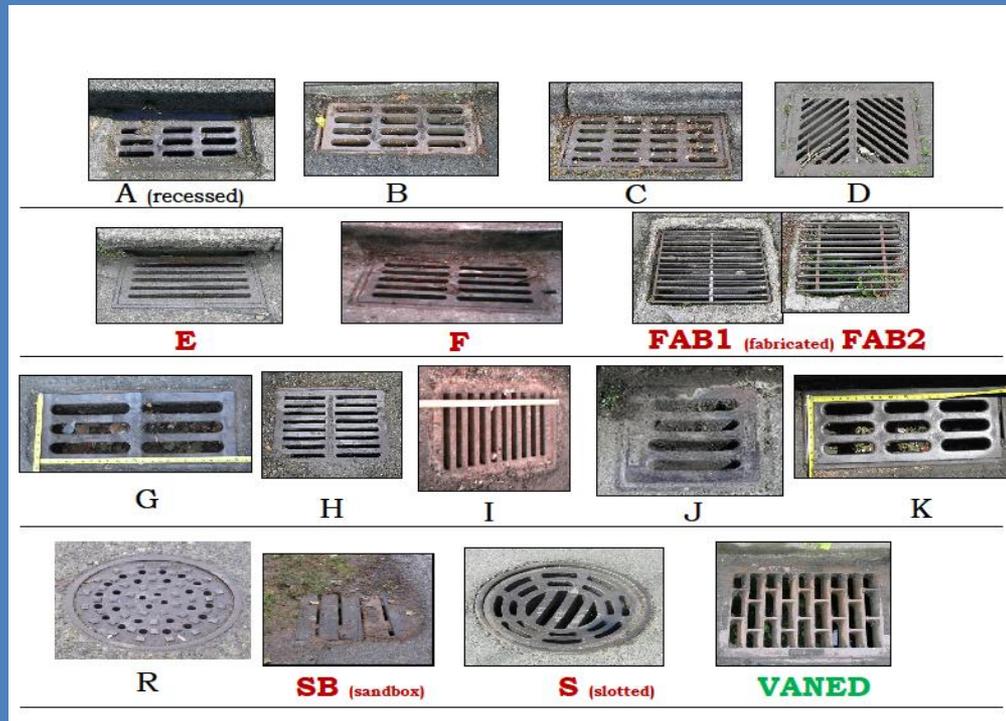
## A. Evaluated SPU structure types and locations

- Identified over 17 different, existing structure types.
- Types **E**, **F**, **FAB**, **SB-sandbox** and **S-slotted** may present a safety concern for bicyclists.
- Type **VAN** or “Vaned” is the City’s current standard.

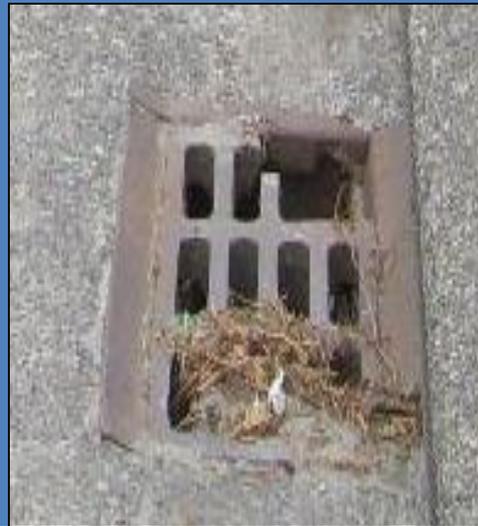
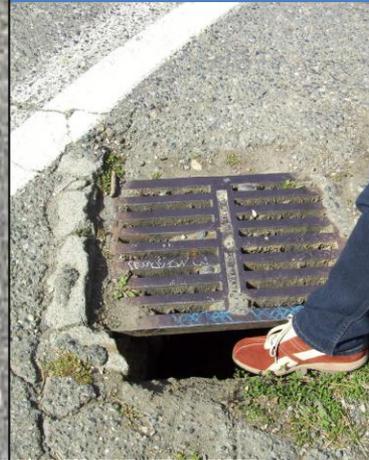
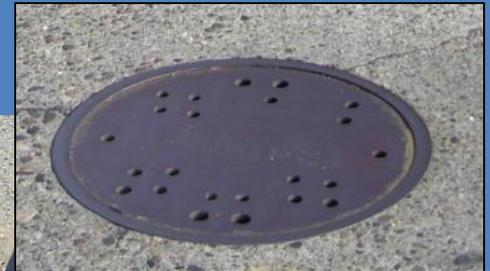
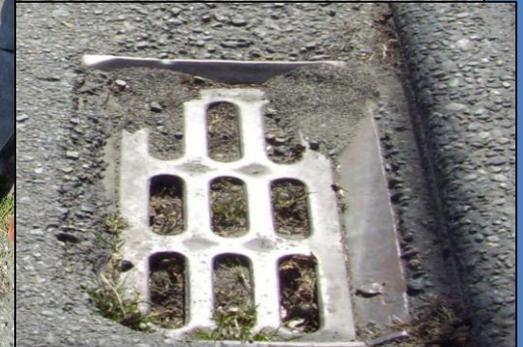
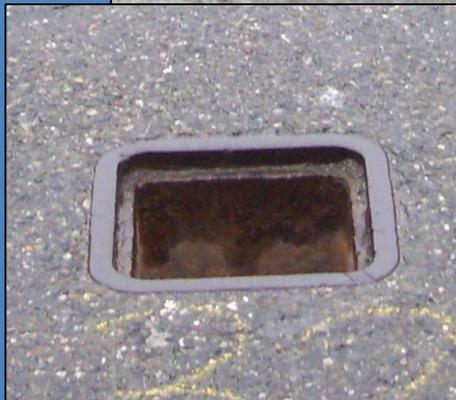
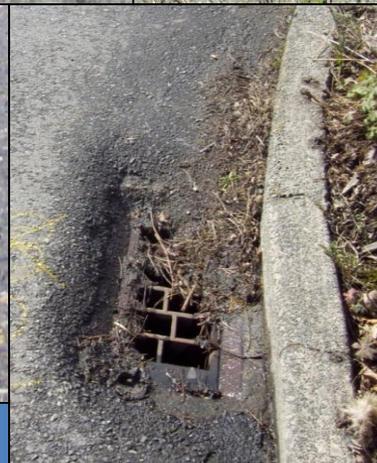
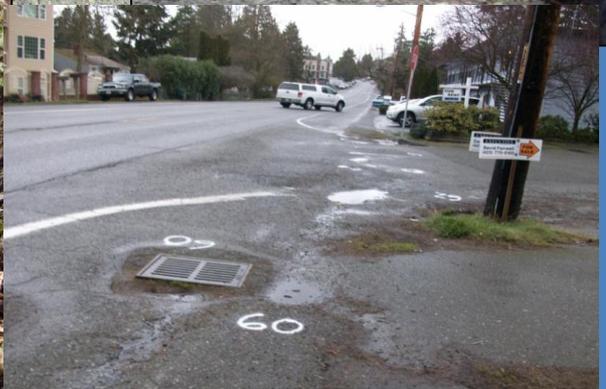
## B. Evaluated the condition of structures and adjacent pavement

- Broken
- Missing
- Worn (slick)
- Clogged
- Sunken
- Raised
- Failing

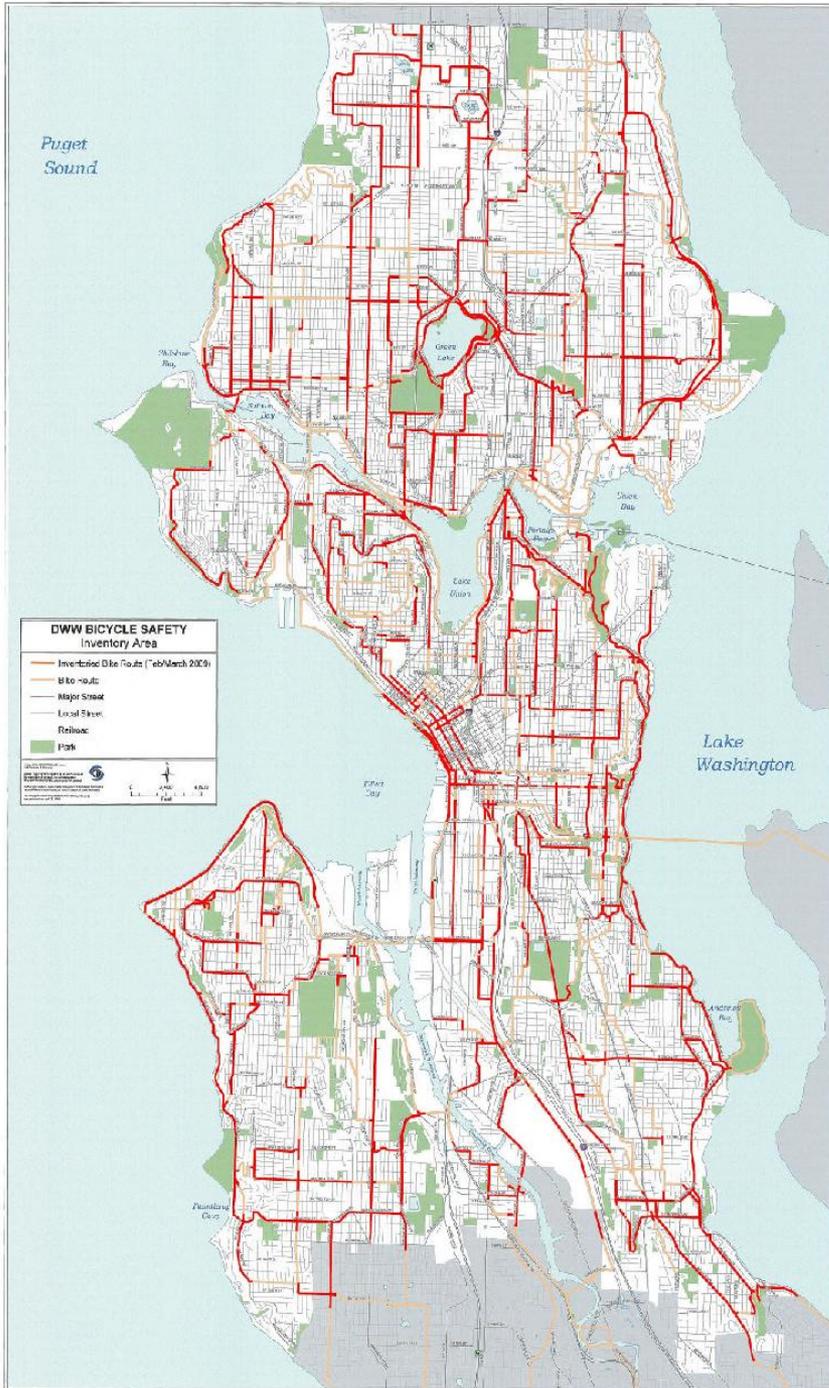
# SPU Survey Results

## Phase 1 (RED)

- 198 miles, over 11,000 assets
- 700 (6% grate type issues, broken, missing)
- 1146 (10% worn, clogged)
- 1711 (15% sunken, raised)

## Phase 2 (LT ORANGE)

- 115 miles, over 8,200 assets
- 304 (4% grate type issues, broken, missing)
- 300 (4% worn, clogged)
- 131 (2% sunken, raised)

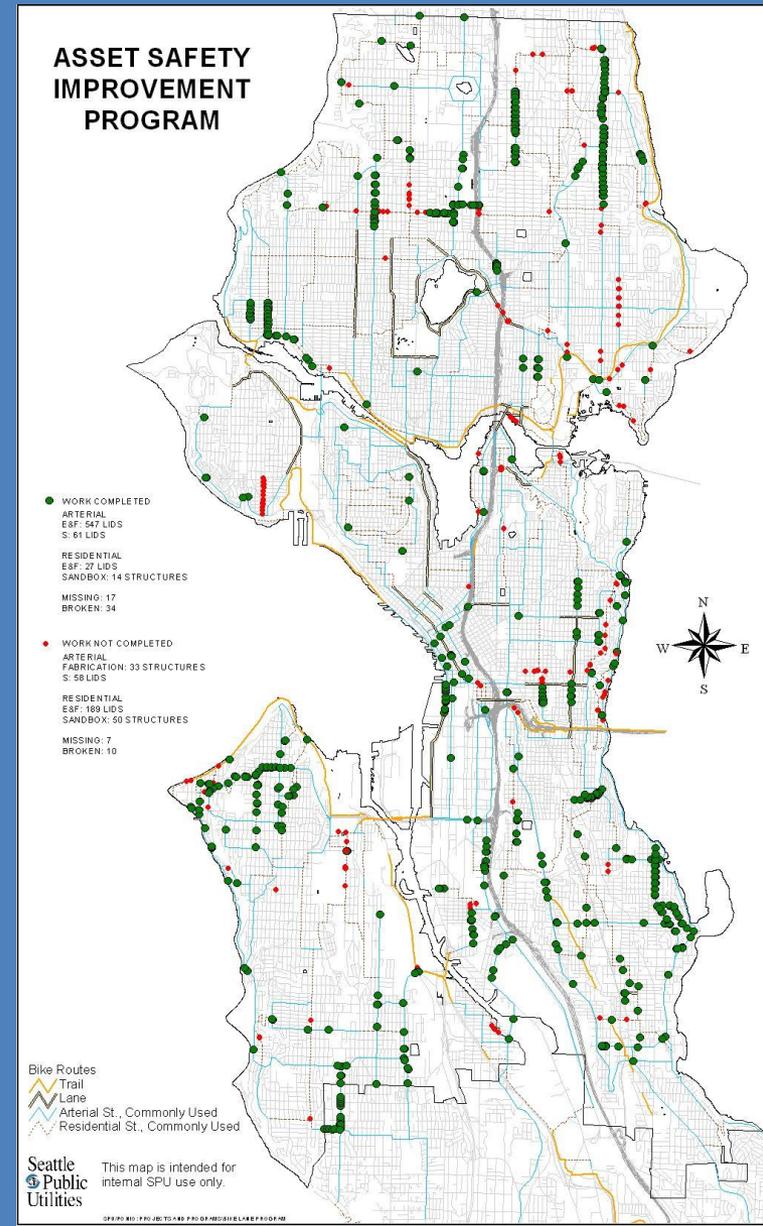
- Replacing certain grate types, broken, missing
- Map → Green = replaced; Red = to do

**\*\*Replaced 686 grates, 14 structures to date\*\*  
(67% of total identified so far)**

## B. Tier 1 priorities (2010, \$82k)
