Feasibility Study

Montlake Bridge Crossing Enhancements for Bike & Pedestrian Users

**INTEGRITY
STRUCTURAL
ENGINEERING
PLLC**

**Seattle Department
of Transportation**

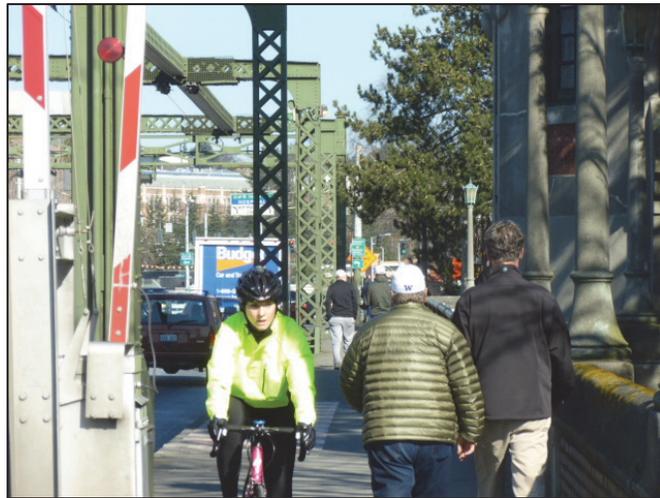
Figure 1.2 Walkway Narrow Point at Southeast Approach

Measurements of the Montlake Bridge walkways find 9'-10" width on the concrete approaches, narrowing to 9'-4" on the bascule bridge; plus approximately 5-inches of added width for the roadway curb at the top of walkway. On the concrete approaches this clear of 10'-3" width narrows to only 6'-4" minimum clear on the southeast approach at the road closing armature (see Figure 1.2). The northeast road closing armature on the approach span is not as restrictive and narrows to 7'-2" clear width. On the bascule bridge, the overhead wire support frames include a 26-inch wide base within the walkway narrowing the usable clear width to only about 7'-2" at the four support frames on the bascule structure (see Figure 1.3). At the trunnion near the ends of the bascule span, the walkway width is again narrowed, but for a longitudinal joint, to a maximum width of 7'-8" between the movable bascule and fixed concrete approach. This joint runs parallel to bicycle and pedestrian movement and includes a raised surrounding protective area with an open joint of approximately 1" at the south approach and 1/2" wide at north (see Figure 1.4). A Plan view of the existing conditions is provided as Figure 1.5.

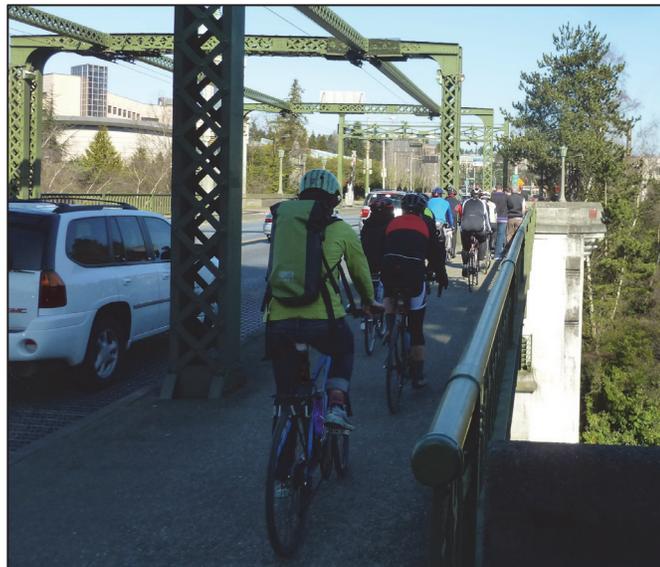
Figure 1.3 Typical Walkway Width at Fixed Object on Bascule Span

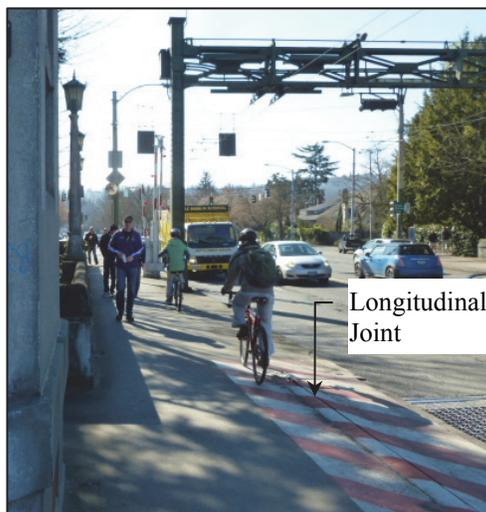
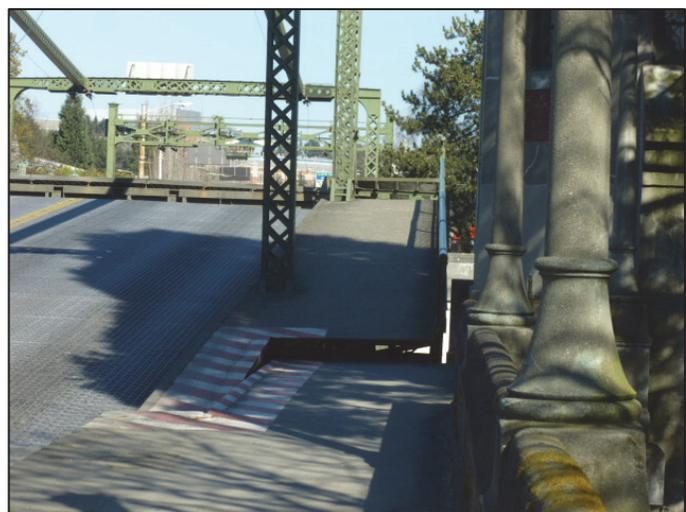
Figure 1.4 Typical Bridge Longitudinal Joint at Trunnion

Traffic movement and flow longitudinally along the bridge is highly disjointed. Each walkway includes nine major obstructions along the length of the bridge, each precluding the full use of the walkway width and requiring significant maneuvering, timing and speed adjustment, as well as layering of users. Five constrictions are at the large steel overhead wire support frames. Two constriction points, one near each end of the bridge, for the large road closure mechanical armature. As well as two approximately 26.5-foot long longitudinal joints, one at each bascule trunnion to allow for the bascule bridge rotation. At some points for a short distance, reducing the walkway width by 37% to only 6'-4" at the road closing mechanical armature (see Figure 1.2) or reduced by 27% to 7'-2" at the steel overhead wire support frame (see Figure 1.3). At the longitudinal joint the walkway width is reduced 31% for a significant 26.5-foot length to only 6'-9" (see Figure 1.4).

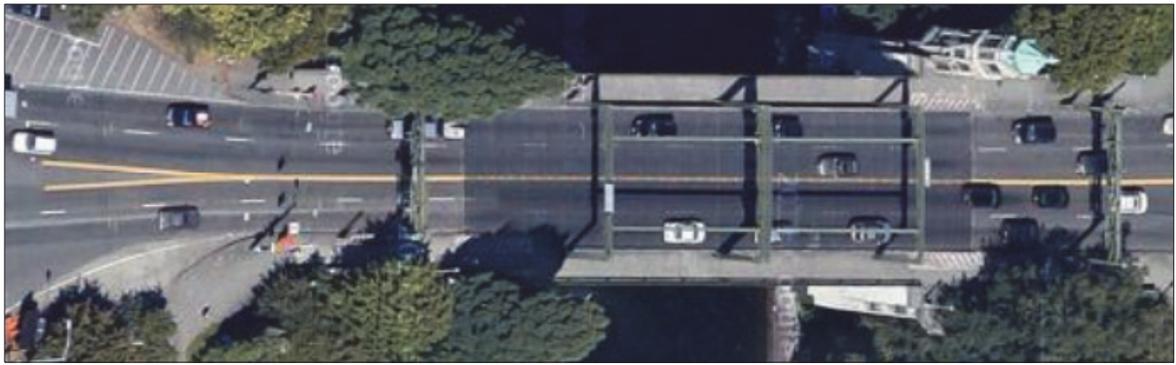
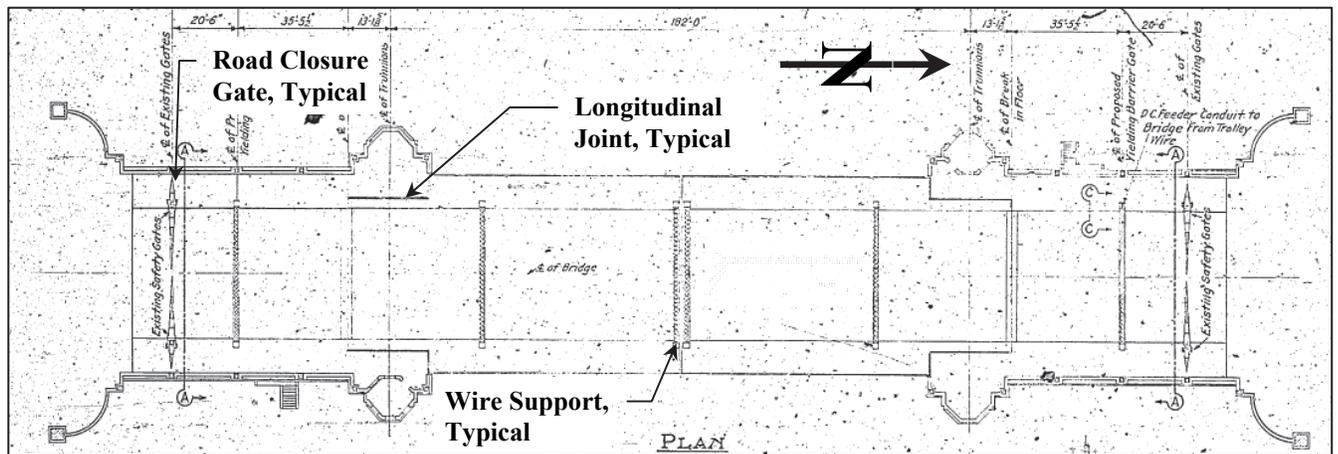
Figure 1.5 Existing Bridge Walkway Plan View

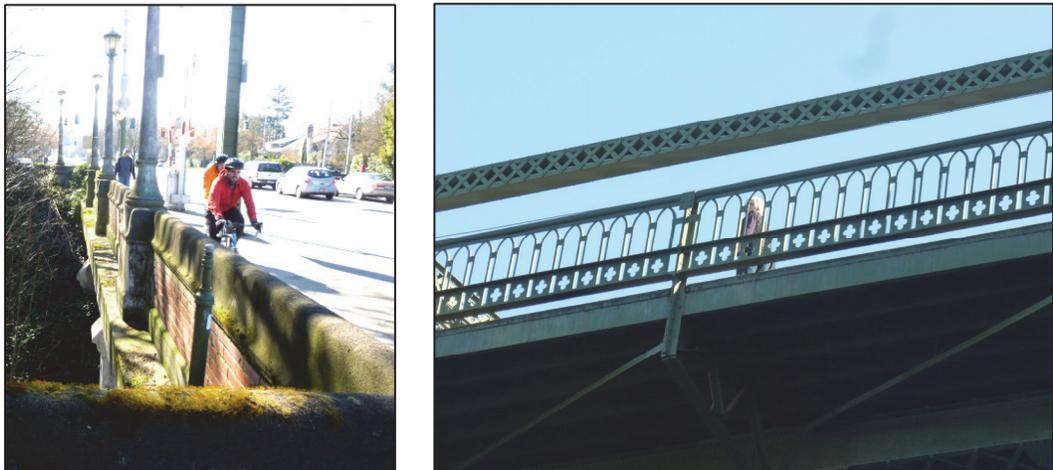
Figure 1.6 Existing Approach Rail and Bascule Rails

The existing rails are the original system constructed in 1925. The ornamental steel rails used on the bascule bridge were shop fabricated and assembled in typical 15'-5.25" long panels matching at the existing bascule floor beams. These rails were brought to the field and then riveted to the walkway supports with four (4) 7/8-inch diameter field rivets as detailed on sheet 19 and 20 of the original 1925 Plans. This makes the rails of the bascule easy to remove and restore after any proposed walkway adjustments. The sidewalk of the bascule consists of 3.5 to 4-inch thick reinforced concrete supported by six steel channels, including one at each edge, each connected to riveted clip angles. The rails, walkway, and walkway support system are in satisfactory condition as noted in the WSDOT inspection report.

The approach rails and walkway are supported directly by the reinforced concrete curtain wall and reinforced concrete edge beam along the outside edge. These loads are transmitted directly to the spread footings. Because these concrete approach rails are poured in-place and integrally connected to the poured edge beams and curtain walls, the rails can only be modified through demolition and then new construction without re-use of the existing historic rails. The approach rails and sidewalks are also listed in good to satisfactory condition in the WSDOT inspection report.

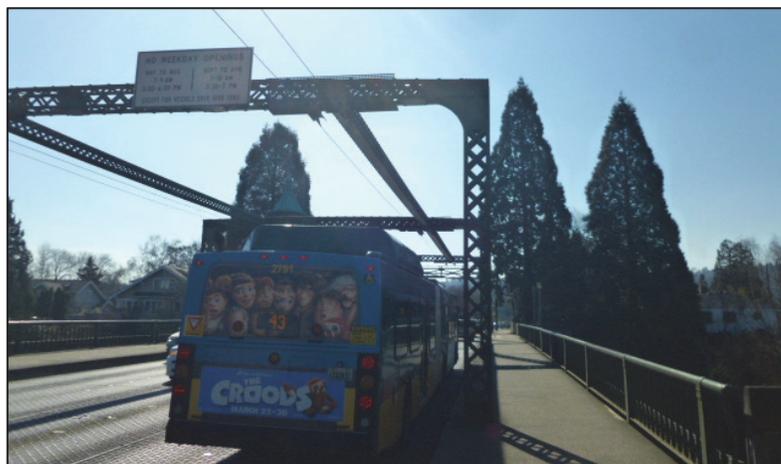
Figure 1.7 Route 43 - Hybrid Powered Bus Crossing

The Montlake Bridge is part of the City and Metro's priority route plan with improvements including Transit Signal Priority (TSP), future extension of the overhead electric trolley wire north of the Montlake Bridge, and an anticipated increase in the number of buses crossing the bridge and using the existing trolley wire. As noted in Section 1 the existing large steel supports for the overhead electric wires create major constriction points on both the approaches and on the main bascule span. It would be operationally beneficial to the crossing pedestrians and bicycle users to eliminate some or all of these constriction points. However, in meeting with the City's transit specialist to understand the current uses, it was noted that Metro is expanding future uses of this overhead wire system. In addition, considering the narrow lanes on the Montlake Bridge for busses, the number of steel supports and their beneficial stiffness, these support systems could not be reduced without negatively affecting the system's reliability, safety of the bus drivers, and traveling public should reconnection be necessary. The frames are supported directly by the bascule truss below. Shifting the frames to span the additional 20-feet to load a cantilever support at the outside of the sidewalk was not possible. Therefore, this operational improvement was eliminated from consideration.

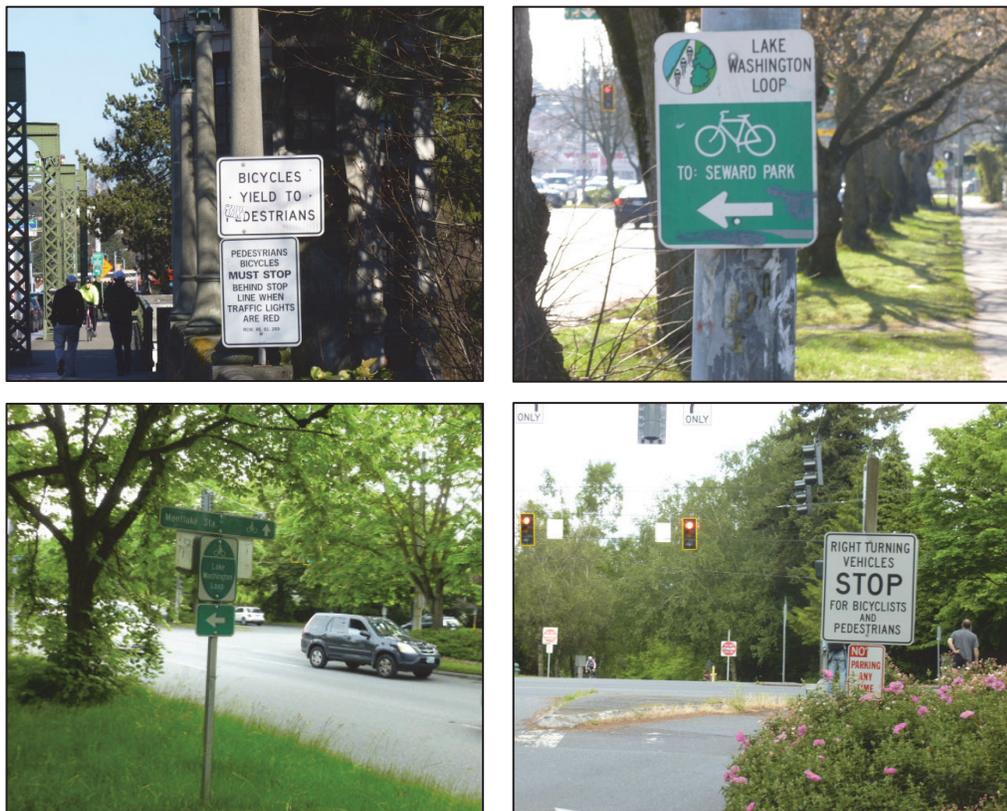
Figure 1.8 Typical Trail and Existing Montlake Bridge Signage

Existing signage from the Montlake Bridge along the Lake Washington Loop are well placed and easy to follow (see Figure 1.8). The established trail selected one direction down toward the lake and a different coming back match the roadway flow, and is successful. Signs from the Burk-Gilman trail to the bridge are not currently complete, but may be in a flux until the new bicycle and pedestrian bridge over Montlake Boulevard is finished. The sight distance can be improved at the Montlake Bridge by cutting back over growth on the adjacent trees, but the current signs are thought to match the present uses well without recommendations.

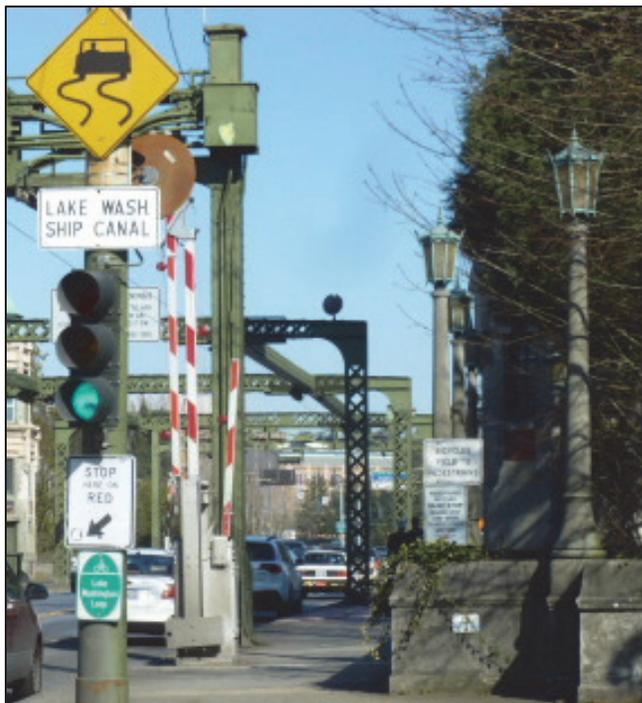
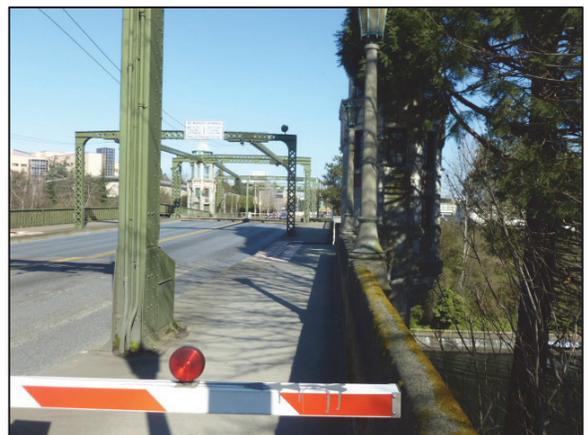
Figure 1.9 Road Closure Gate at Southeast Approach

Existing road closure gates and armatures are located within the sidewalk at each of the four corners of the bridge. The mechanical elements of the road closure gates are contained within large steel boxes and are operated from the control tower to close the road and sidewalk. The road closure armatures consist of one longer double folded armature for the roadway lanes and a single armature for the sidewalk (see Figure 1.9). These are existing safety elements, along with the traffic signal, that are operated to close the sidewalk and roadway areas to traffic before opening the bascule bridge. The foot print of the existing road closure gates is approximately 26-inches wide transverse by 32-inches long parallel to the length of the bridge. The four gates are constriction points on the bridge walkway with the narrowest on the southeast corner at approximately 6'-4" from face of approach rail to face of gate mechanical box. Other locations are less restrictive at approximately 7'-2" from face of approach rail to face of gate mechanical box, with similar clear width to that of the wire support frames. These road closure gates are safety features that cannot be eliminated. However, it is possible that other gate mechanical systems are available to replace the existing ones, which may have smaller foot prints and longer armatures that would thereby improve clearance between the existing approach rail and closure gate. A mechanical system might also be designed that could be attached at the first wire support frame on the north and south approach and therefore combined it into just one constriction point rather than two separate, which would eliminate four constriction points of the bridge. This mechanical research was not part of the current study, but could be added to explore improvements at these four constriction points without widening the concrete approach sidewalks.

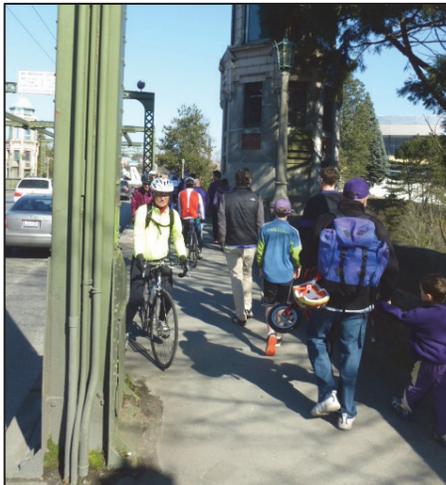
Figure 2.1 View of Current Peak Usage at Typical Constriction

The minimum standard width for multipurpose (combined bicycle and pedestrian users) has been recommended by the City at 10-feet and national standards from the AASHTO Guide for Planning, Design, and operation of Bicycle and Pedestrian Facilities have increased standards to 14-feet of usable full walkway width. Current level of service has been documented as operating at Level-of-Service (LOS) D with individual speed selection and ability to bypass others restricted, as well as frequent changes in speed and position required. With anticipated increases in pedestrian usage from the SR520 and Sound Transit improvements, by the year 2016 the level-of-service is expected to fall to LOS F with significant waiting times, walking by shuffling, unavoidable contact with others, and would not serve most bicyclists.

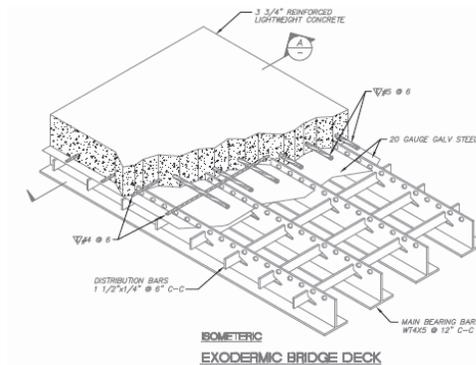
Figure 2.2 Galvanized Steel Exodermic Deck System

Materials considered for the bascule bridge have included carbon fiber, FRP, timber, steel, concrete, and prestressed concrete. Timber has an excellent weight to strength ratio, but does not match the maintenance requirements of the existing system and was eliminated. Carbon Fiber was possible from strength and durability standpoint, but was unreasonably expensive and could not be successfully applied to this case. FRP beams could be created that would match the strength requirements with necessary weigh benefits but was extremely flexible at 1/10 the Modulus of steel and could not be utilized without extreme changes to the existing structure for additional bracket supports and was therefore eliminated. Concrete is much lighter than steel with a high durability, but because of the span required between existing brackets it could not be successfully utilized. Prestressed concrete may be possible, but because the bridge is lifted and lowered as a bascule span the center of gravity relative to prestressing will create forces that could destroy the system. The most applicable system developed for this project's criteria was the use of an Exodermic deck system. This system consists of a composite steel deck that is cast integral with a topping of lightweight concrete and acts as the formwork for the pour, which allows for high

strength, rapid construction, and the durability of a composite concrete deck. The calculations worked out directly with the manufacture demonstrate that the combined system would be 6.45-inches thick, can be used to widened bascule bridge walkway 18% from 9'-4" to 11'-0" wide without increase in weight. The deck would need to be temporarily shored at quarter points, a very simple matter, during casting of the lightweight concrete, but will support the AASHTO 90psf live load capacity and has a deflection of only L/951 under full live loading. The proposed exodermic deck system consists of shop-fabricated panels that are galvanized, easily placed in the field as single units and cast composite with lightweight concrete meeting all criteria including weight, useful life expectancy, maintenance, and inspection.

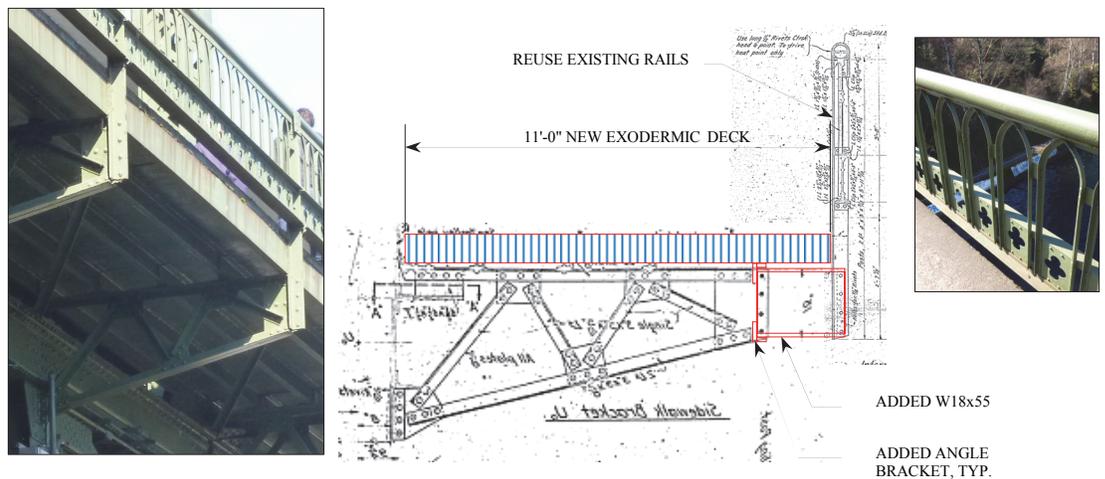
Figure 2.3 Existing and Revised Bascule Bridge Walkway

The existing Montlake Bridge ornamental steel rail was shop fabricated as typical rail panels and installed in the field via four 7/8"-diameter rivets at support bracket every 15'-5" on center. The work of this walkway widening would therefore remove the four field rivets, take the rail in typical panels to the shop for preparation and painting. After shop preparation of the rail and installation of the composite galvanized exodermic deck, the existing bridge rail would be brought back to the field and again installed with four 7/8-inch diameter high strength bolts without modification. This work uses the existing historic bridge rail and support, does not change the historic appearance of the structure in anyway, and would be permitted per the *Secretary of the Interior's Standards for Rehabilitation*.

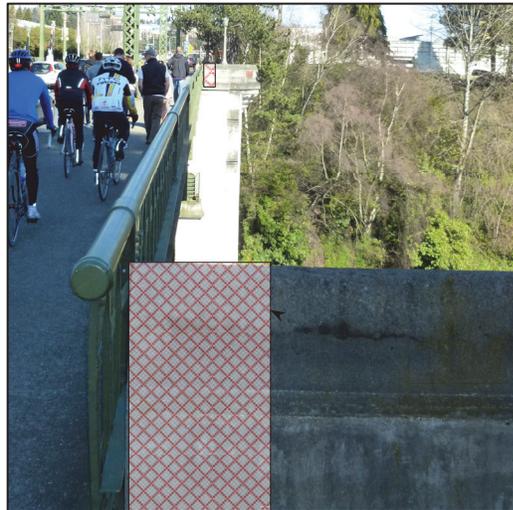
SAW CUT AND
REMOVE 1'-8" OF
EXISTING
CONCRETE RAIL,
TYPICAL

Figure 2.4 Portion of Rail Removal for Walkway Widening

At the Montlake approach bridge, the walkway and rail system were cast as integral with each other during the original construction. Architectural relief, edging, and features of the rail are significant throughout the bridge approaches and match the towers. Since the approach walkway cannot be widened without permanent damage and removal of the existing rails that aid in creating the Gothic architectural characteristics of the historic bridge and landmark designation, it may not be permitted. Initial discussions with WSDOT/DAHP indicated an understanding of the proposal, and the possibility of acceptance at the state level, but the replacement details and mitigation requirements could not be identified. Because the widening is not fundamental to the bridge's structural rehabilitation and preservation, and the current proposal would damage the structure's historic characteristics, it is possible that this work may not be permitted. This proposal and permitting for the rail replacement should be explored separately with the State, the US Dept of Interior, and the Seattle Department of Neighborhoods to determine feasibility.

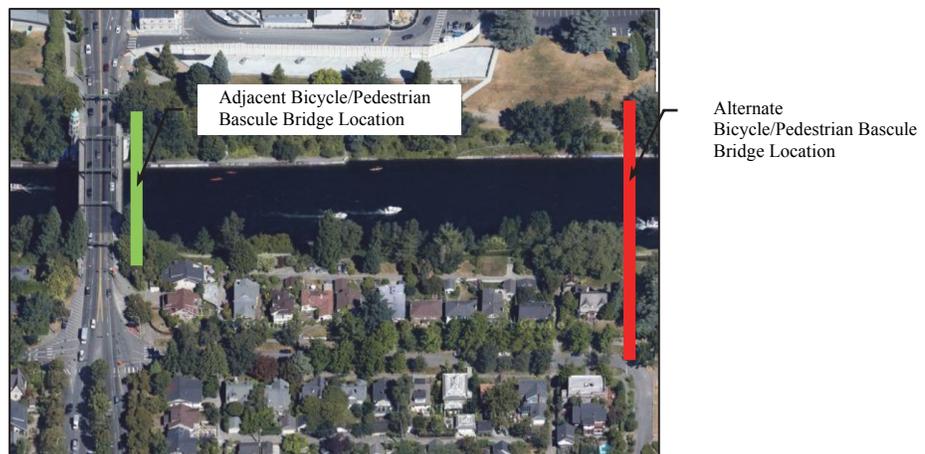
Figure 2.5 Approximate Bascule Bridge Locations

The construction of a separate bascule bridge structure for bicycle and pedestrian traffic is possible. Two crossing locations were evaluated and considered. The first location was immediately adjacent to and east of the existing bridge and a second location still further east near McCurdy Park. The location immediately east of the bridge (see Figure 2.5) has the best connections to the existing trail and Lake Washington loop such that the existing Montlake Bridge walkway could be utilized exclusively for pedestrians. It also has access advantages and similar geographic contours with the existing bridge eliminating some approach structures that would be necessary at the other location. Finally, this location allows for simultaneous operation of the lift bascule from the existing southeast tower reducing on-going maintenance costs and the initial capital costs. One significant detriment to this location is that its footprint is at the same point as the WSDOT proposed new northbound bascule bridge structure and would therefore have to be demolished in the future if the SR520 second bascule bridge over Montlake cut continued forward.

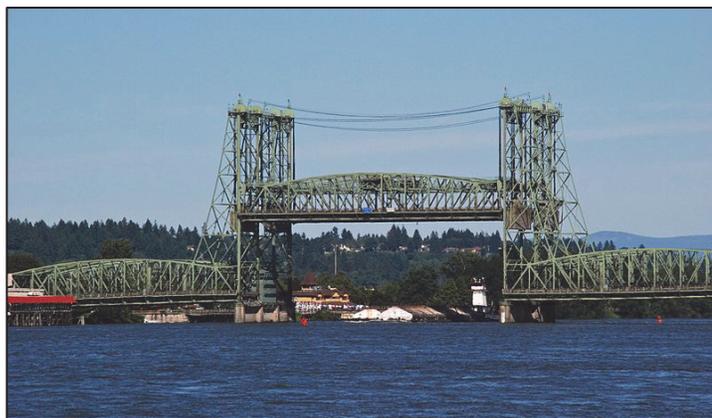
Figure 2.6 WSDOT Vertical Lift Bridge at Vancouver WA

The bascule would be similar in length with the Montlake Bridge at about 200-feet long and with the approaches would be have a total length of about 360-feet for the adjacent location or about 500-feet for the bridge located farther east. The bridge would be constructed having a closed position clear above the water of 53-feet, which is better than the Montlake Bridge's 46-foot clear in the closed position. In past coordination from the City of Seattle with Corps of Engineers and US Coast Guard, the vertical lift position needed a 140-foot clear above the water. Therefore, this conceptual bridge design is assumed to lift the bridge 140-feet above the water, or another 90-foot above its down and locked position. This equates to an approximately 100-foot tall tower that would be located 1,800-feet from UW's fountain. It may not be visible depending upon specific elevation, but would have to be reviewed with the University of Washington for approval and affect on the Mount Rainer view at the campus fountain. (Example Vertical Lift Bridge across the Columbia River to Vancouver Washington, the raises 136-feet above the roadway.)

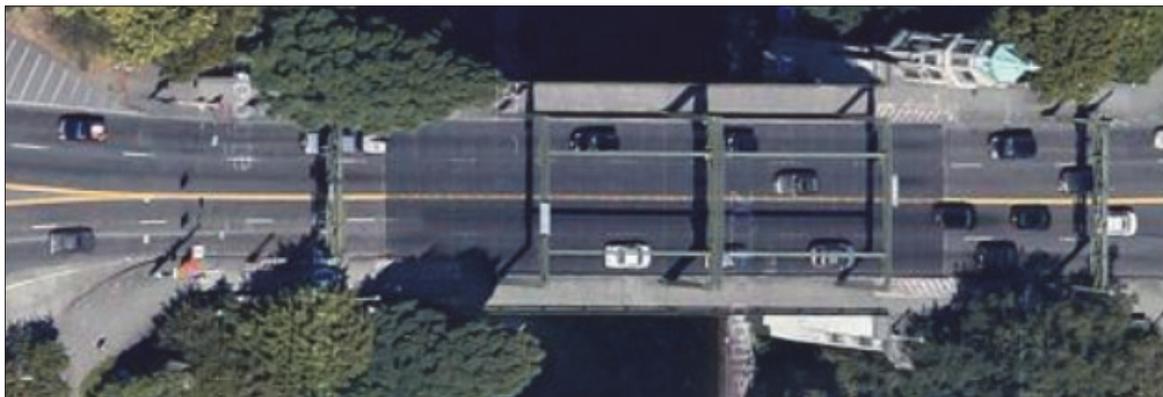
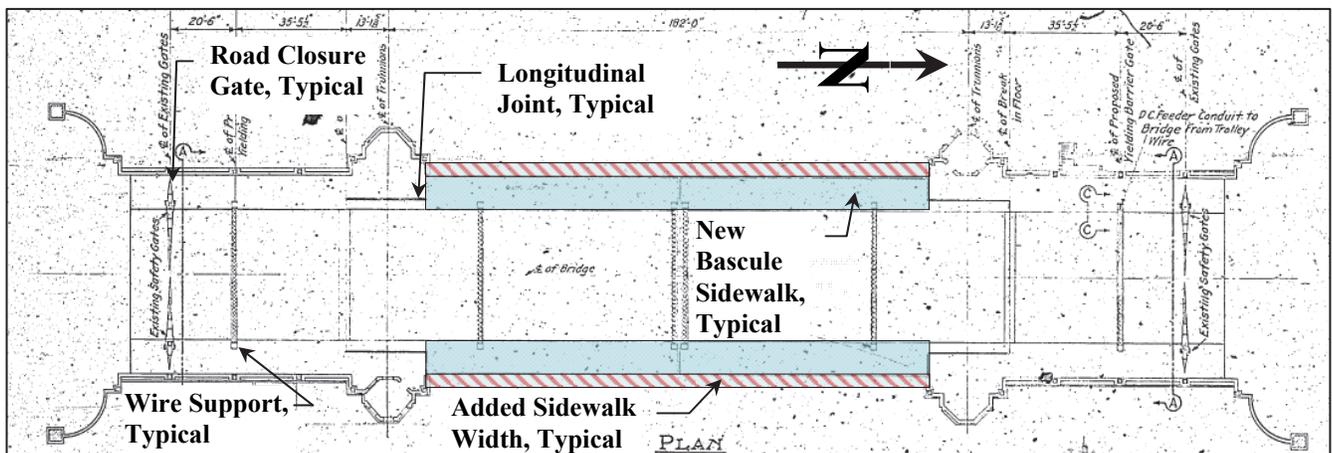
Figure 3.1 Recommended Bascule Walkway Widening

Widening of the existing bascule bridge walkway is feasible and is recommended. In this proposal, a lightweight exodermic deck system is used to replace the existing walkway with a wider walkway, at the same weight without increase. The existing rail of the bascule bridge is also preserved and its connection is conducive to the proposed widening construction as shown in Figure 2.3 and 2.4. The recommended walkway system will provide a widening along the east and west bascule walkway of almost 2-feet. This provides approximately 605-square feet of added walkway area at a project cost of approximately \$3,648,000 (see Table 3.1). This proposal enhances the usefulness of the existing structure by mitigating contraction points without negative impact to the structure's historic character or landmark status. The ten challenging constriction points improved include six at wire support structures and the four longitudinal joints. Unfortunately, the extent of added width recommended is limited because of the criteria established. The criteria was to equate existing and new walkway weights and thereby maintain the existing load rating, eliminate possible challenges for the existing mechanical and electrical systems, and help assure WSDOT's acceptance. To increase the widening available a study of the bascule lift system's capacity could be initiated and any reserve discovered used to increase the bascule widening. The current widening proposal is also for the bascule structure only. This is because permitting for the demolition and replacement of the approach rail, necessary for approach walkway widening is not anticipated as allowed. Again, this permitting criteria limitation of the proposal must be reviewed in detail and contacts made with the State and US Interior agencies. If permitting is possible, a widening for the shorter approach structures could also be undertaken and the Montlake Bridge concrete approach rail system replaced.
