CITY OF
SEATTLE
FACILITY
ASSESSMENTS

INTRODUCTION

The objective of this document is to provide construction cost estimates for specific repairs at (5) five mutual and offsetting benefit (MOB) properties owned by the City of Seattle. The repairs considered were identified based on the direction given by Statement of Legislative Intent (SLI) #2012-58-1-A-2.

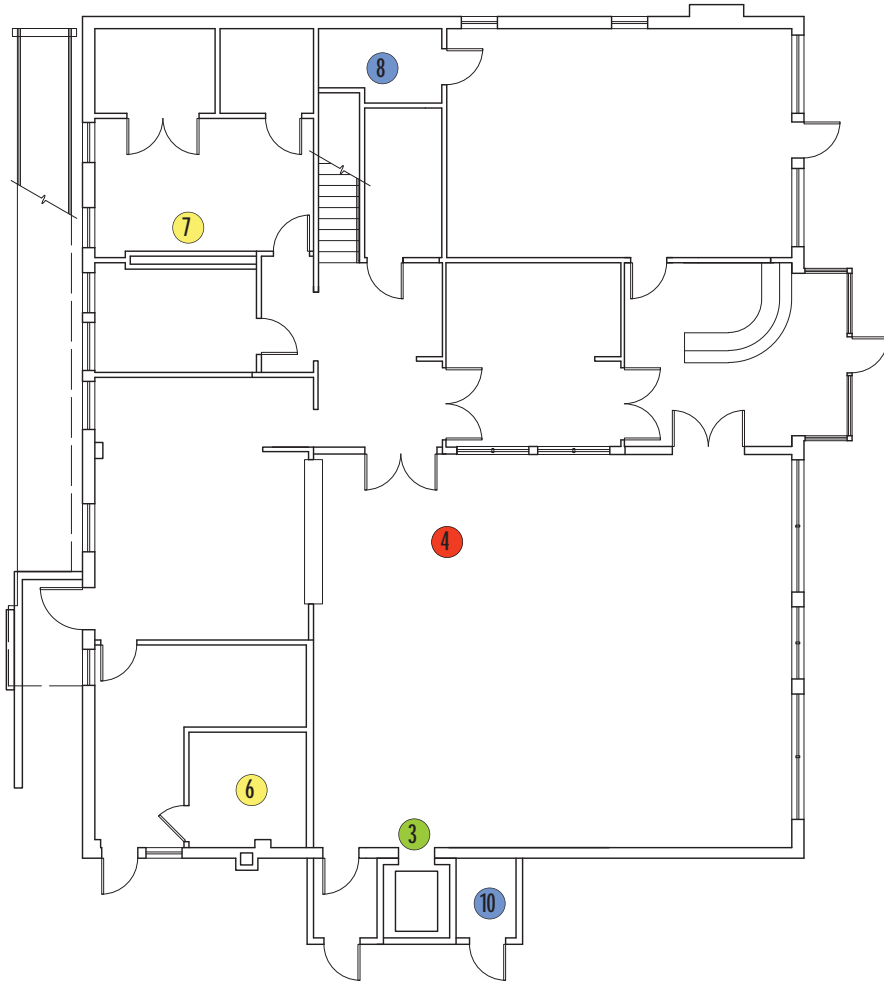
GROUND FLOOR PLAN
SCALE: 1/16" = 1'-0"

| Repair / Maintenance | | Estimate |
|---|---|---|
| 1 | Replace loose parquet wood floor tile; door threshold too high - 10 sf | \$750 |
| 2 | Install panic hardware on this exit way door | \$250 |
| 5 | Replace (3) non functional radiators on second floor | \$1,500 |
| 6 | Boiler is 25 years old and nearing end of life. Budgetting for future replacement should be considered. | \$15,000 |
| 7 | Provide duct smoke detector in (2) ventilation air handling units for shutdown | \$3,000 |
| 8 | Remove abandoned 120/240V fused breaker pullman panel - no short circuit rating | \$1,200 |

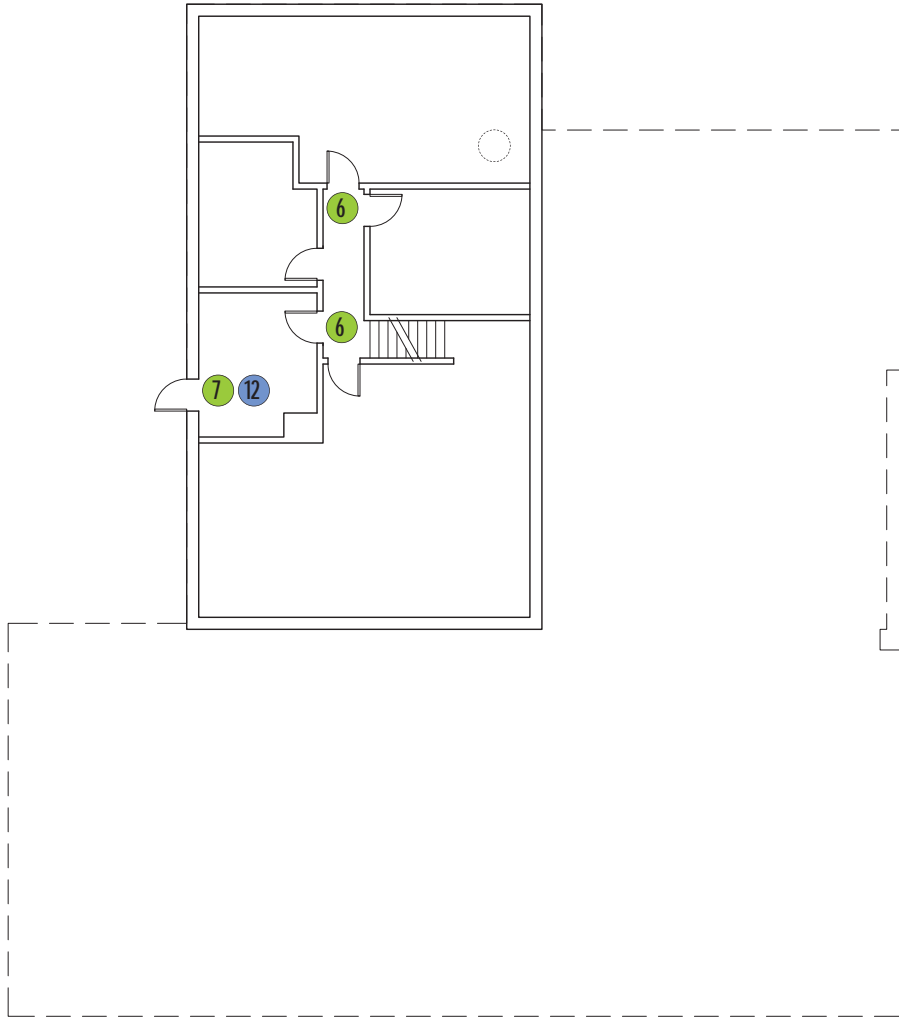
BASEMENT FLOOR PLAN
SCALE: 1/16" = 1'-0"

| Repair / Maintenance | Estimate |
|--|---|
| 7 Panic hardware necessary OR accessible window and light well needed for egress | \$250 |

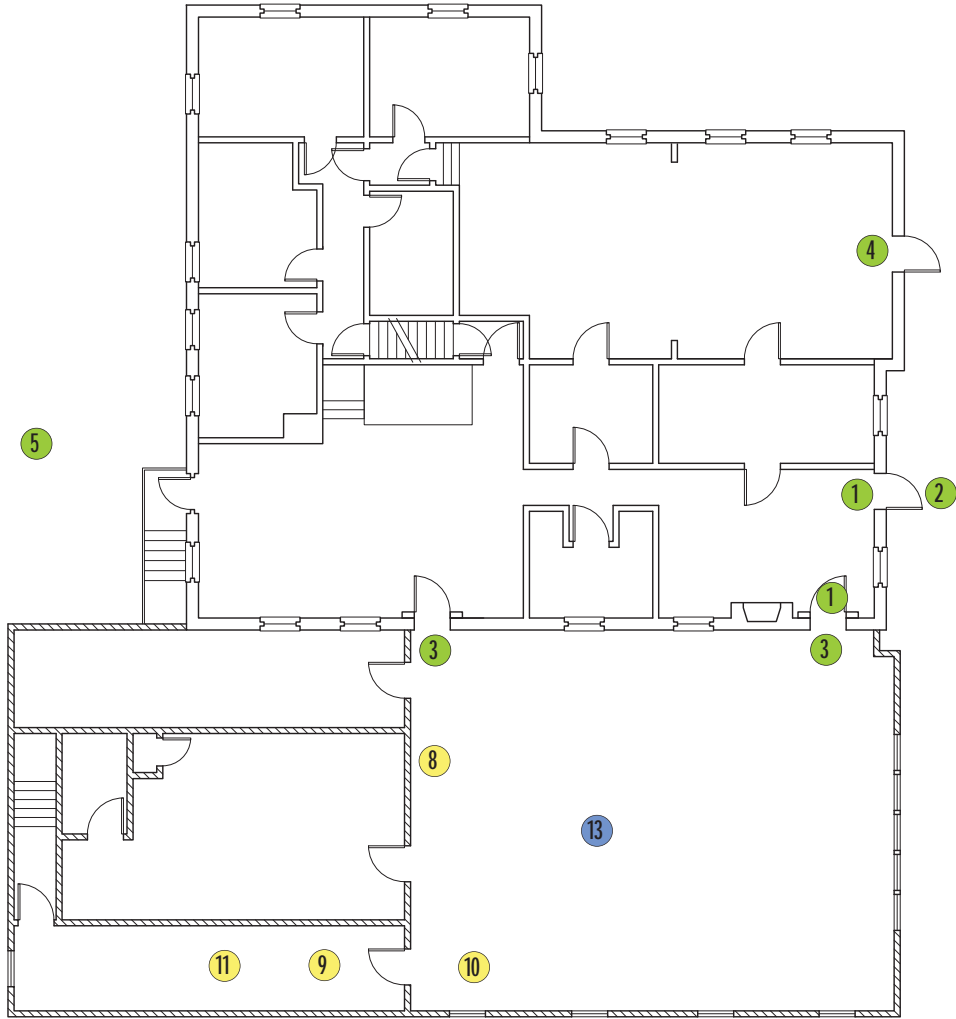
GROUND FLOOR PLAN
SCALE: 1/16" = 1'-0"

| Repair / Maintenance | Estimate |
|--|---|
| 1 VCT flooring missing tiles | \$200 |
| 2 Door pull too high for ADA accessibility; push side clearance lacking | \$450 |
| 3 Panic hardware and closers missing; door width not wide enough | \$3,000 |
| 4 Exit signage needed above door; threshold at exterior not accessible for WC | \$225 |
| 5 ADA parking stall provided but no accessible route to building | \$600 |
| 6 Exit signage needed above door | \$300 |
| 8 Replace multi-purpose room gas furnace | \$15,000 |
| 9 Cap return duct in greenhouse, rebalance return ductwork | \$500 |
| 10 Remove transfer grill in greenhouse, infill wall | \$500 |
| 11 Provide electric unit heater and thermostat for greenhouse | \$600 |
| 12 Replace heat detector | \$600 |
| 13 Flush floor 120V outlets - remove wiring and outlet, fill with concrete | \$1,440 |

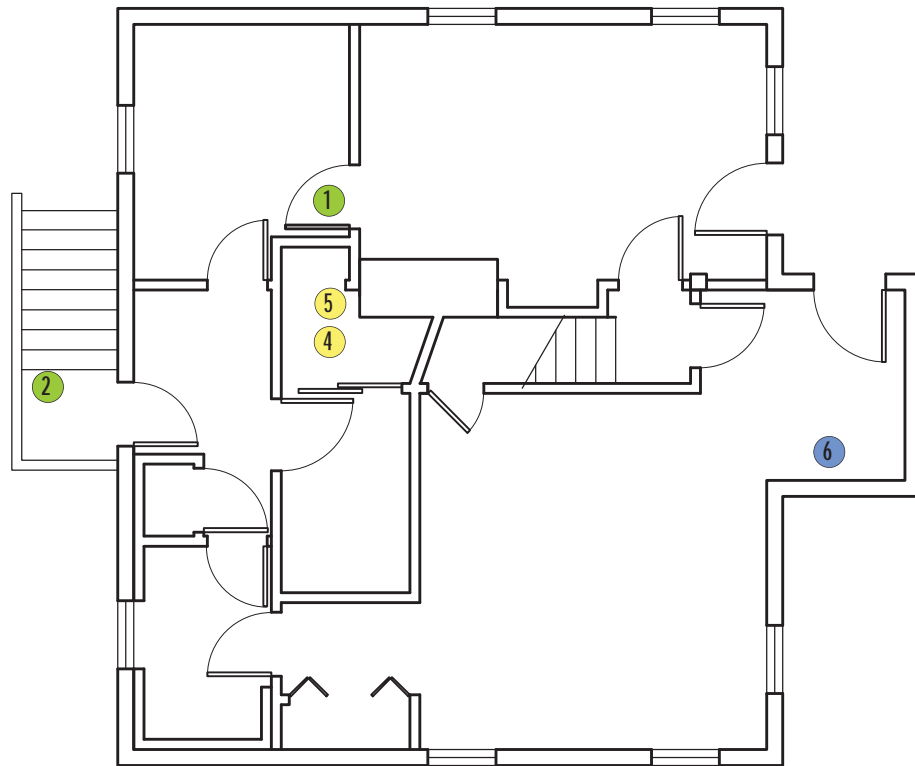
BASEMENT FLOOR PLAN
SCALE: 1/8" = 1'-0"

| Teen Parent Home | | |
|---|--|---|
| 4 | Furnace is 25 years old and nearing end of life. Budgetting for future replacement | \$15,000 |
| 5 | Provide flex pipe gas connection to furnace | \$200 |

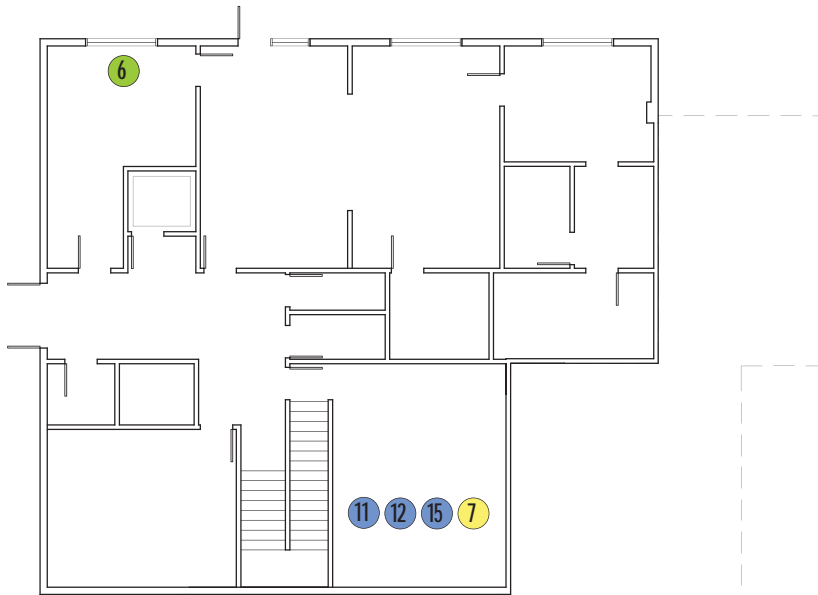
BASEMENT FLOOR PLAN
SCALE: 1/16" = 1'-0"

| Repair / Maintenance | Estimate |
|---|---|
| 11 Replace non-AIC rated power panels from 1959 (120/208V, 3ph, 300A SE, 200A Pnl) - includes demo cost | \$16,800 |

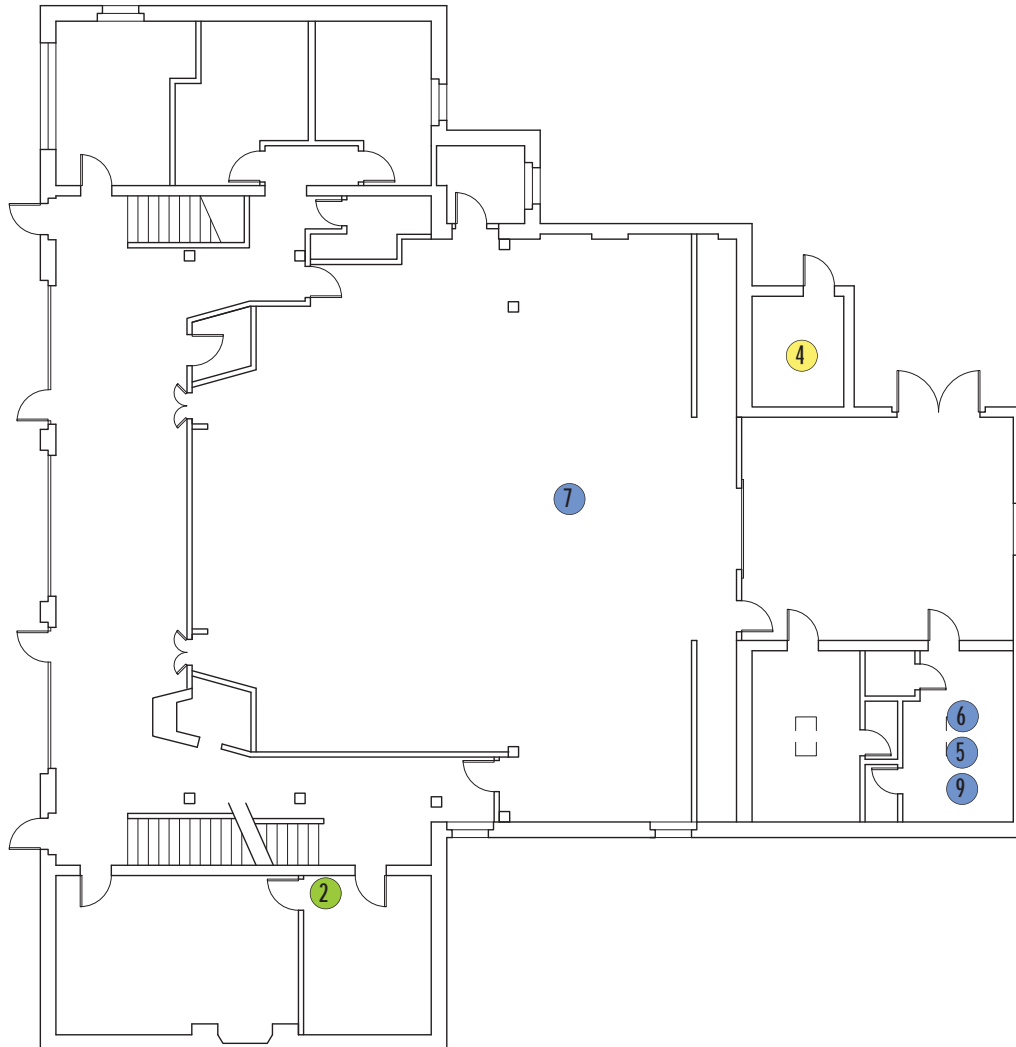
GROUND FLOOR PLAN
SCALE: 1/16" = 1'-0"

| Repair / Maintenance | Estimate |
|--|---|
| 1 Cracked glazing at skylight | \$825 |
| 2 Step in door at threshold is tripping issue (noted but NO repair) | \$0 |
