Landmarks Preservation Board Report on  
Designation of Union Stables, located at 2200  
Western Avenue.

### REPORT ON DESIGNATION

Name and Address of Property: **Union Stables**  
**2200 Western Avenue**

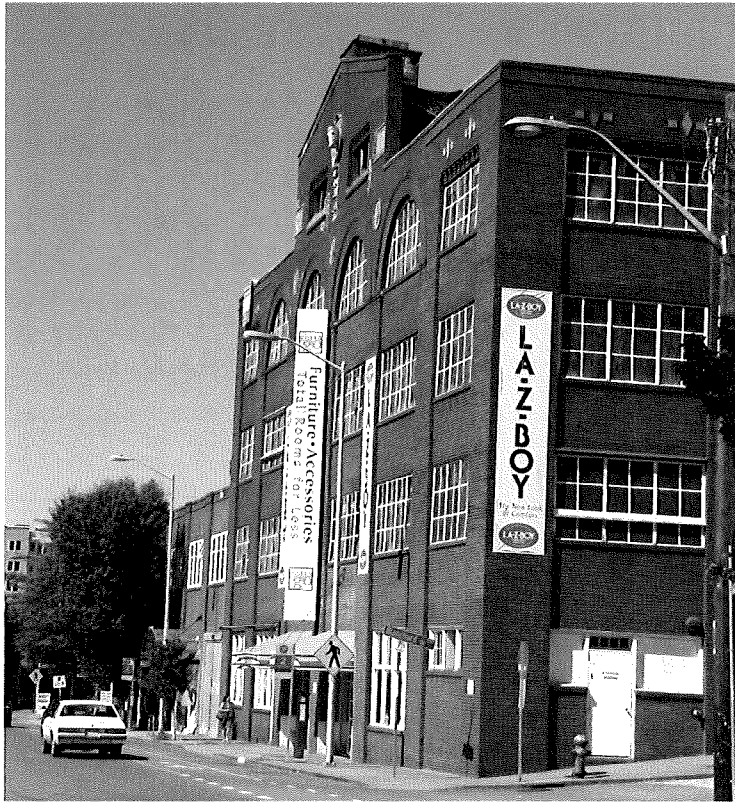
Union Stables, 2200 Western Avenue, current

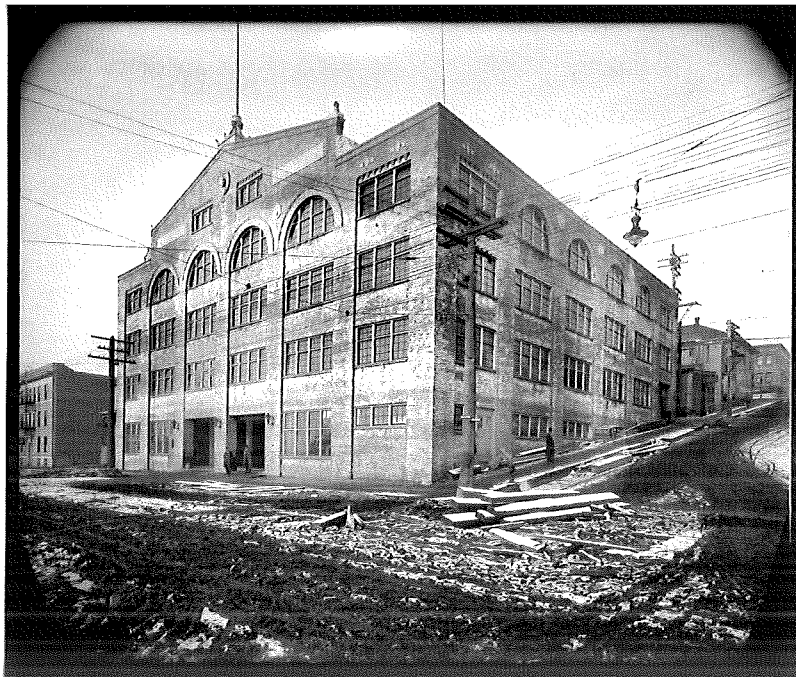
Union Stables, 2200 Western Avenue, c. 1913, MOHAI
